DAM SAFETY INSPECTION REPORT

ECHO LAKE DAM

FILE NUMBER: 0142-002

INSPECTED: OCTOBER 23, 2014

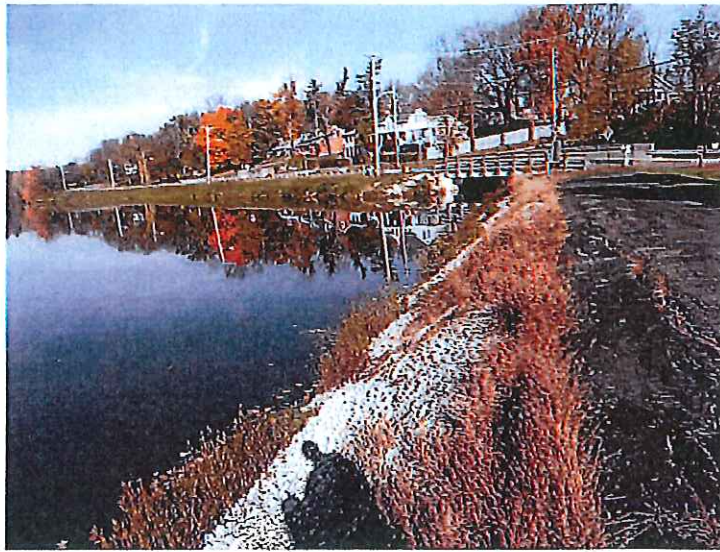
1. Upstream slope looking towards the left end of the dam. Note the light brush in the riprap.

Small riprap (size D or smaller) on the slope. No signs of erosion. Light brush throughout slope. Continue to cut or spray. A hose was found about 2' below the crest. It appeared to be encased in a PVC pipe and buried in the embankment. May be used to fill a swimming pool at the house located on the downstream slope.

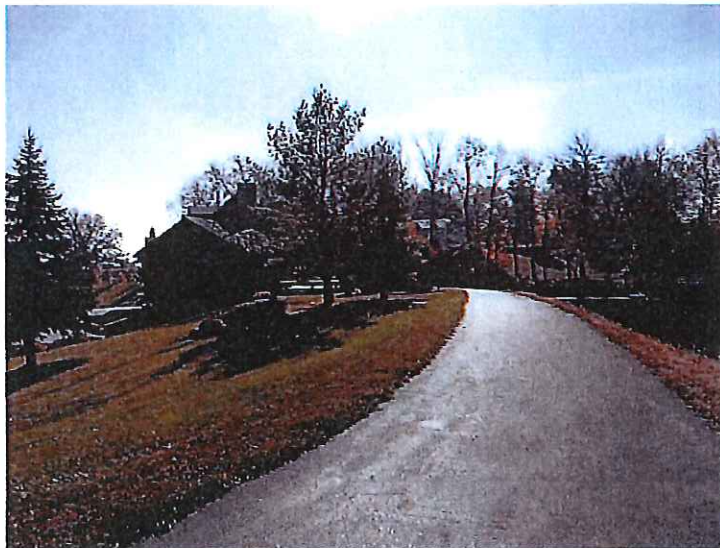
2. Downstream slope and crest. Note the house and the mature trees on the downstream slope.

There is a house with a swimming pool on the slope. There ~~are~~ are also mature trees and bushes. Remove the trees and brush.

1. Remove the trees and brush from the embankment of the dam and the canal. Seed all disturbed areas to establish a proper grass cover. See the "Trees and Brush" fact sheet for additional information.
2. Mow all vegetation on the embankment to maintain a maximum height of 12 inches. See the "Ground Cover" fact sheet for additional information.
3. Remove the pipe and hose from the dam embankment. Backfill the area with impermeable fill.
4. Investigate the standpipe and the opening at the base of the spillway wall in-line with the standpipe. Include a description in an Operation and Inspection Manual for the dam.
5. Investigate the dam and canal embankment ownership. See Discussion Item B for more information.

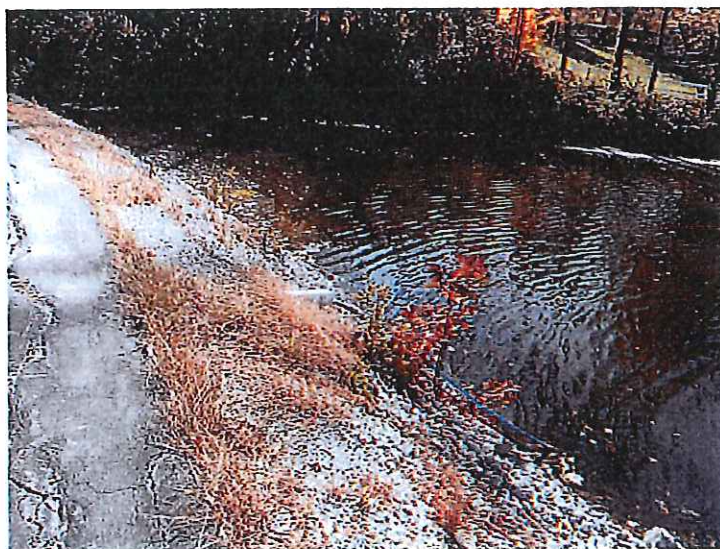
3. Buried hose encased in a PVC pipe on the upstream slope. It appears to be a hose used to fill a swimming pool for the house on the downstream slope.

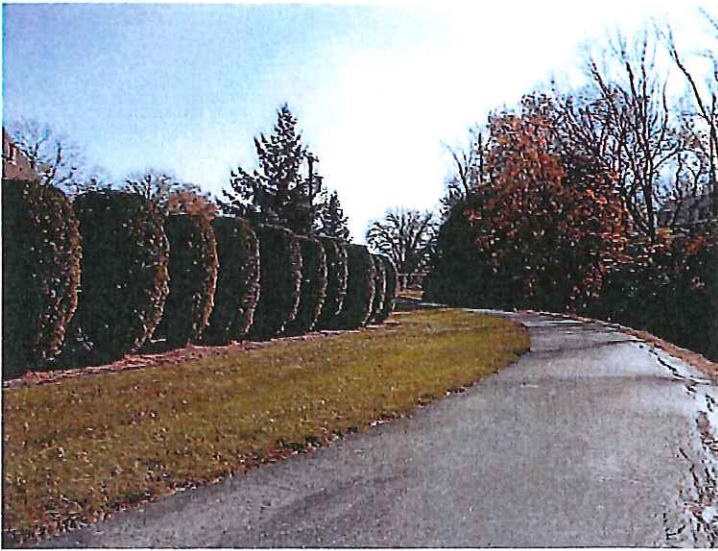
4. Note the landscaping on the downstream slope.

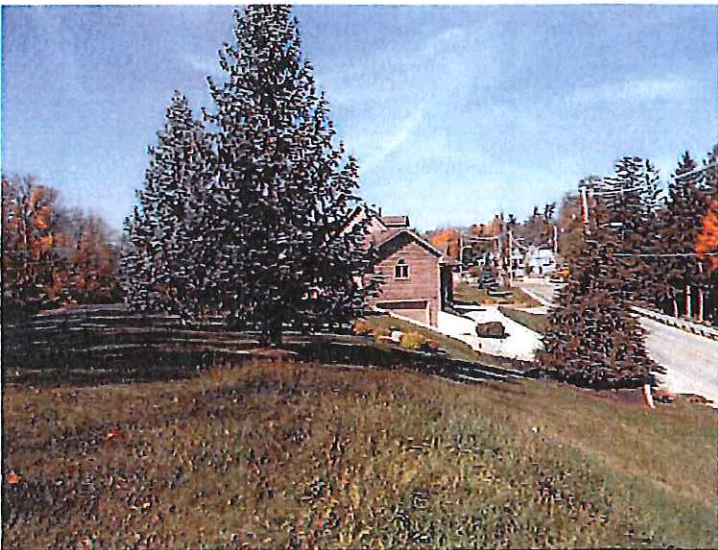
5. Crest and downstream slope as viewed from the canal to the right of the dam.

The crest on the dam appeared to be mostly level. However, as it connects to the canal, the crest was not level. Unclear how the dam will operate in overtopping conditions.

2. The embankment crest alignment must be uniform. Investigate the variable vertical alignment of the crest of the dam and canal and, as necessary, prepare plans and specifications for the correction of any problems. This item should be completed in coordination with Item 1 above. See Discussion Item A of this section for additional information.

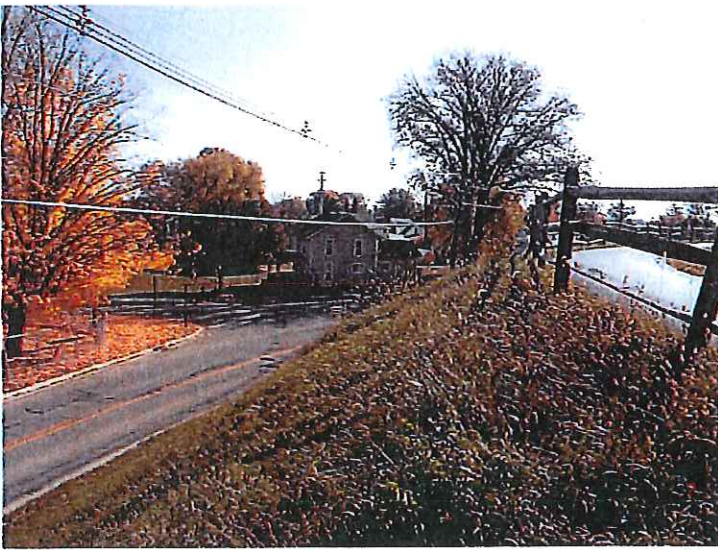
6. Downstream slope of the canal leading from Echo Lake to Franz Pond.

Clear the canal embankment of trees and brush.

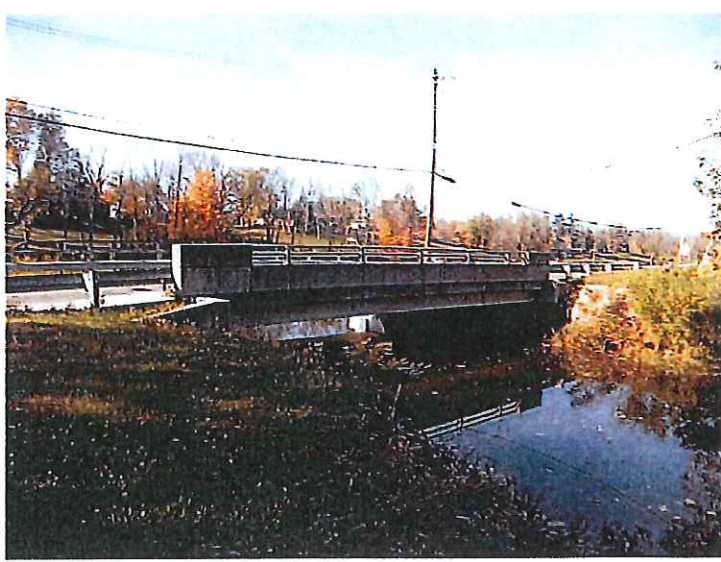
7. Downstream side of the bridge over the canal at the left end of the dam. The canal leads to the spillway about mid-way between Echo Lake and Swift Run Lake.

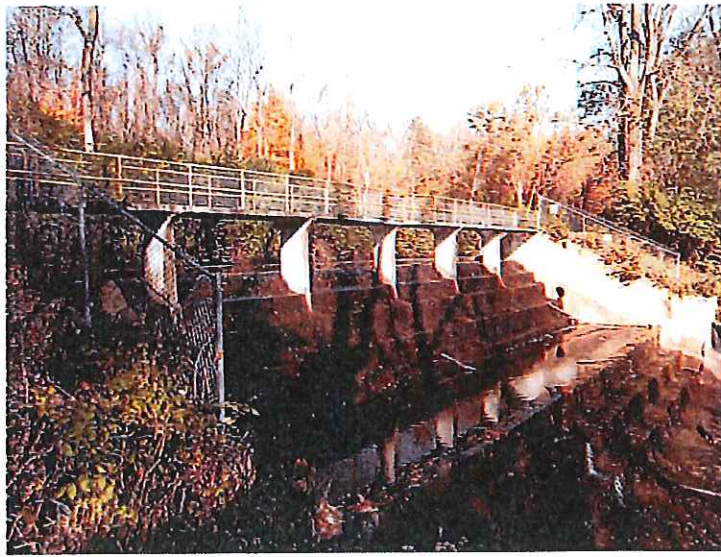
8. Spillway located on the canal. This is the only outlet for Echo Lake and Franz Pond.

The spillway appeared to be in good condition.

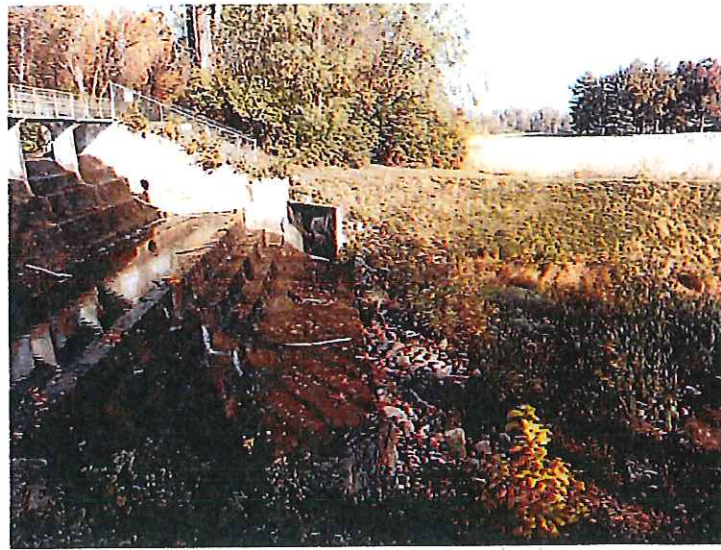
9. Left sidewall of the spillway.

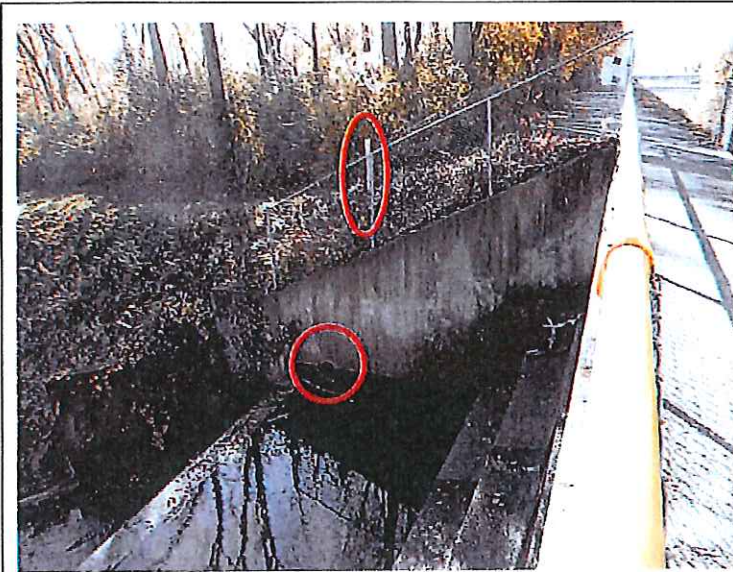
10. Right sidewall of the spillway.

Note the standpipe to the left of the sidewall and the opening at the base of the sidewall. It was unclear if these two were related or what purpose either serve.

There was a standpipe to the right of the right spillway outlet wall. There was also an opening at the base of the spillway wall in-line w/ the standpipe. Investigate these 2 items and include a description in an OMI for the dam.

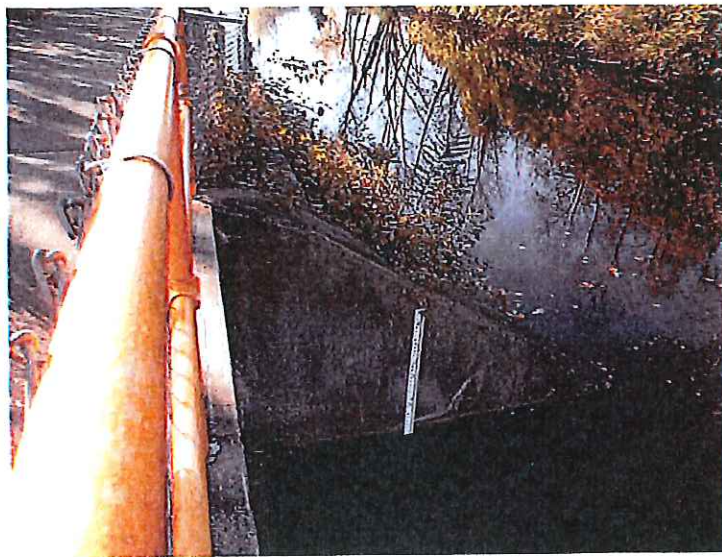
11. Staff gauge found on the right sidewall of the spillway inlet.

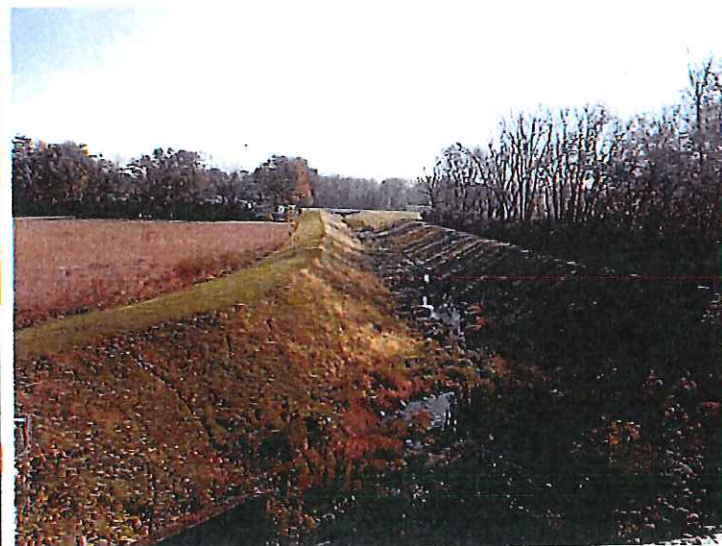
12. Outlet channel for the spillway.

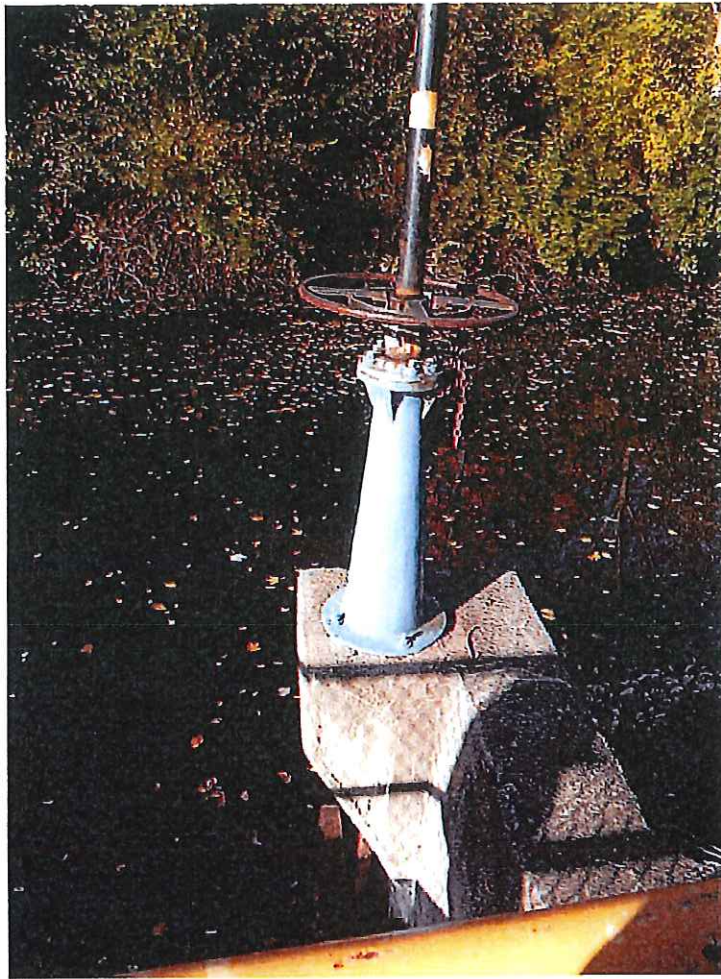
13. Lake drain operator located on the left wingwall of the spillway inlet.

It is unclear whether the valve would be able to lower the water in Echo Lake. Investigate or provide an adequate lake drain device.

3. This dam must have a device to permit draining of the reservoir within a reasonable period of time in accordance with OAC Rule 1501:21-13-06. Investigate the ability of the valve at the canal spillway to adequately lower the water level in Echo Lake and document in an Operation, Maintenance, and Inspection Manual for the dam. Or, prepare plans and specifications for the installation of such a device. See the "Lake Drains" fact sheet for additional information. The owner must complete this item and implement all engineered plans for improvement within 5 years.

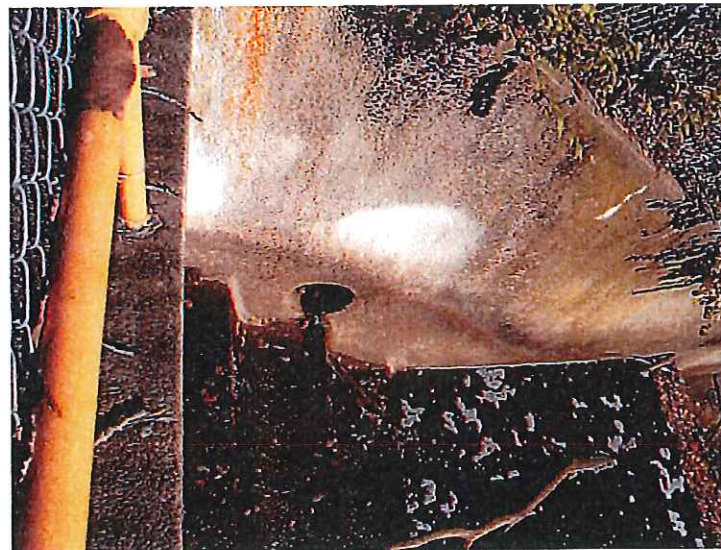
14. Lake drain outlet on the left spillway outlet sidewall.
