Re: City of Piqua–Franz Pond Ditch Stormwater Evaluation

Technical Memorandum City of Piqua, Ohio

Franz Pond Ditch Stormwater Evaluation

December 2019

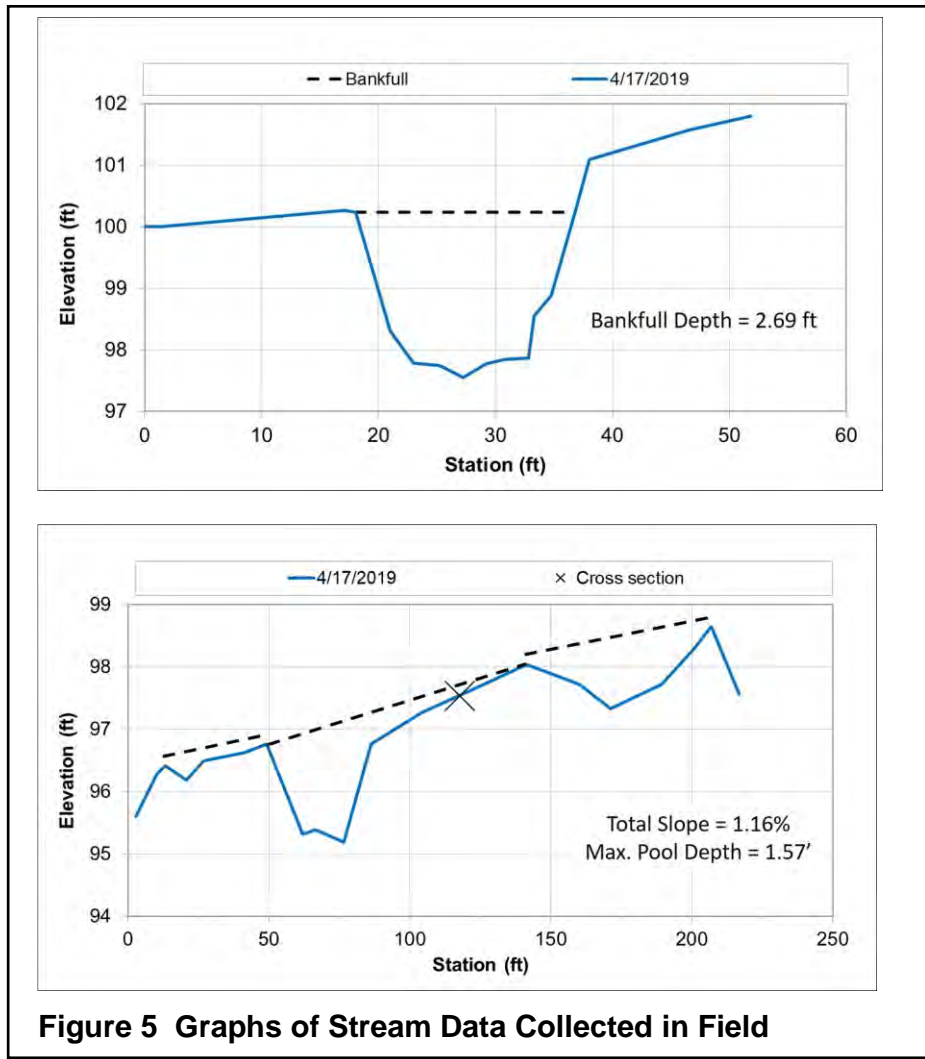
Figure 5 Graphs of Stream Data Collected in Field

Data was collected in the field to better understand the physical characteristics of the ditch and to help determine the critical flow rate ($Q_{critical}$) that begins mobilizing streambed particles, leading to the evident downcutting and bank erosion along the ditch. Extensive armoring and chronic channel instability limited the ability to collect representative data at multiple sites, so one specific location of the ditch was used to collect the data. Cross sectional data was collected, along with a longitudinal profile and an assessment of the bed material size and gradation. At the location where data was collected, the bankfull depth of the ditch was approximately 2.7 feet, the slope of the ditch along the profile was approximately 1.2 percent, and the average bed material size (also referred to as d_{50}) was approximately 67 millimeters. Figure 5 displays graphs of data collected.

The data suggests that a representative estimate of $Q_{critical}$ is approximately 40 percent of the peak flow rate during a 24-hour duration design storm with a recurrence interval of two years in undeveloped conditions. This estimate is consistent with other regional estimates of $Q_{critical}$. The recurrence interval is a simplified term portraying the probability that a given storm event will be equaled or exceeded in any given year. For example, the 2-year storm interval does not necessarily mean a storm only happens once every two years, but rather a storm with a 50 percent chance of occurring in any given year. The rainfall volumes corresponding to design storms are based on the *Rainfall Frequency Atlas of the Midwest*

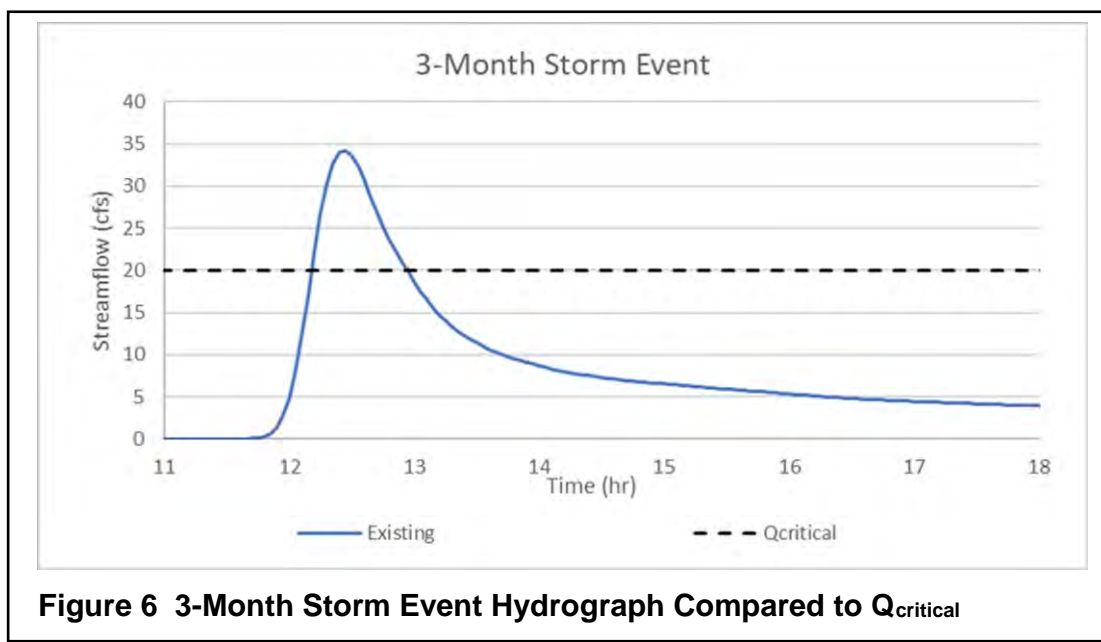
Based on these estimated peak flow rates, even the smaller design storms exceed the $Q_{critical}$ threshold. As a result, rainfall events that produce erosive flows and cause streambed particles along Franz Pond Ditch to mobilize have the probability of occurring at least several times annually. Figure 6 displays a runoff hydrograph of the three month storm event in relation to the $Q_{critical}$ estimate. The portion of the hydrograph that exceeds $Q_{critical}$ represents the duration when erosive flows are occurring.

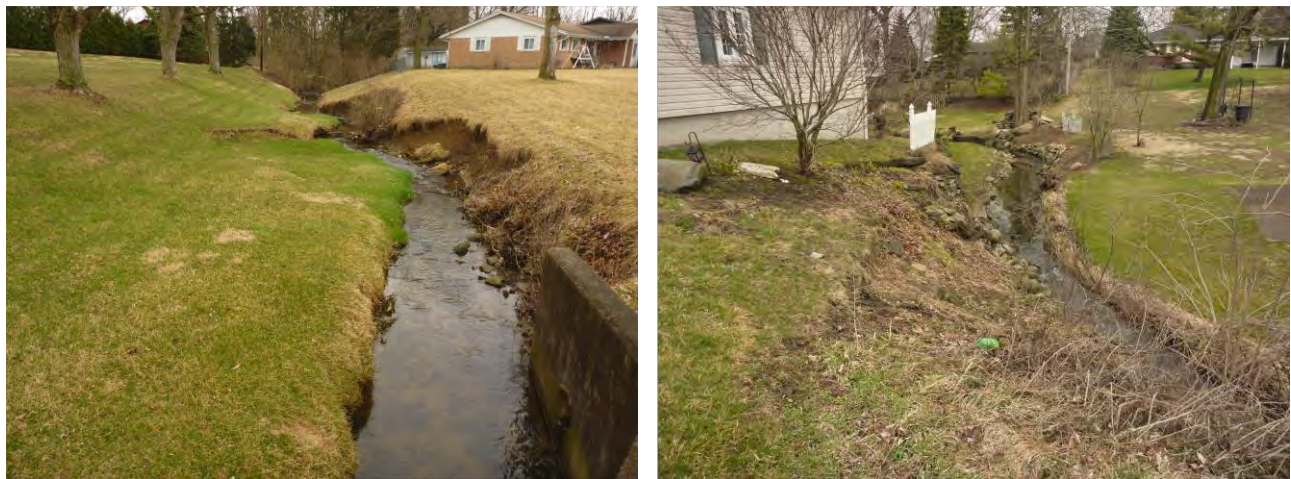
Figure 8 Significant Bank Erosion Along Peters Street Ditch to the South

The existing storm sewer system along High Street (east of Sunset Drive) to the south of Franz Pond Ditch is also relatively shallow (less than 10 feet) according to the City's GIS data. The pipe diameter ranges from 18-inches in diameter at the upstream end to 27-inches in diameter at the downstream end. Rerouting stormwater runoff from the north or west to this location would require a significantly deeper and larger storm sewer conveyance system over a length of approximately 3,500 linear feet. An open channel system or drainage ditch is located farther south of High Street near Peters Street. This drainage ditch is already experiencing erosion issues that have impacted several residential properties near Peters Street as displayed in Figure 8. Therefore, contributing additional stormwater flow to this drainage ditch is not recommended.

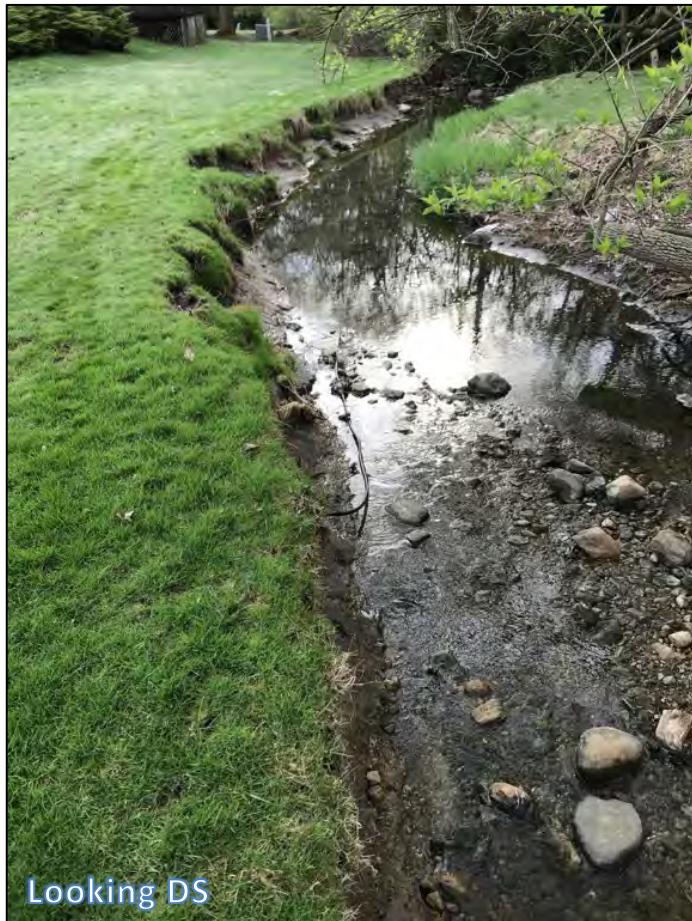
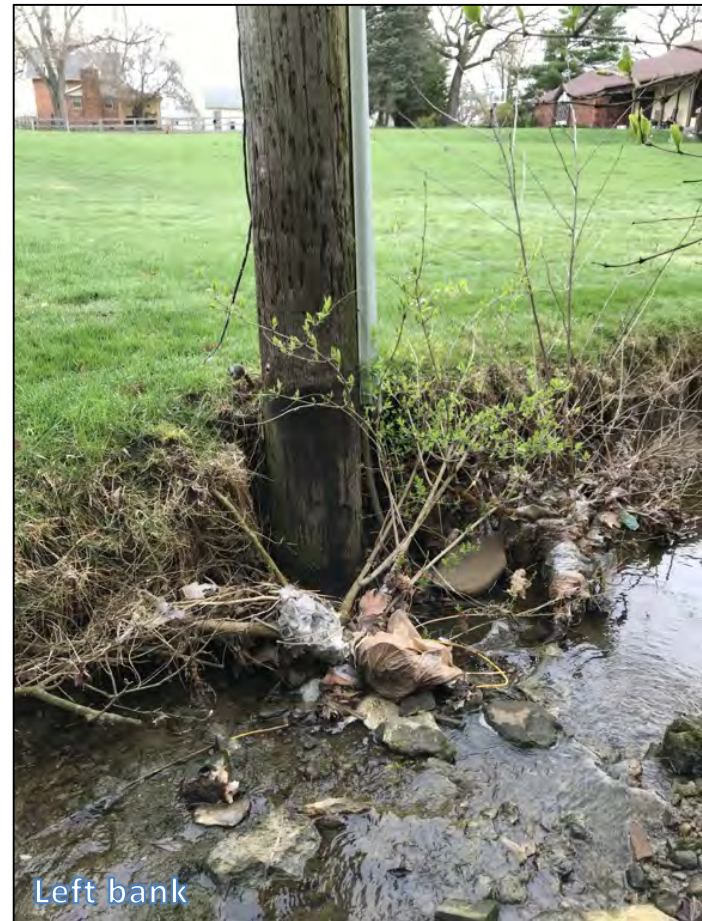
- Left bank lacking riparian buffer (mowed to edge) experiencing erosion
- Base of telephone pole exposed

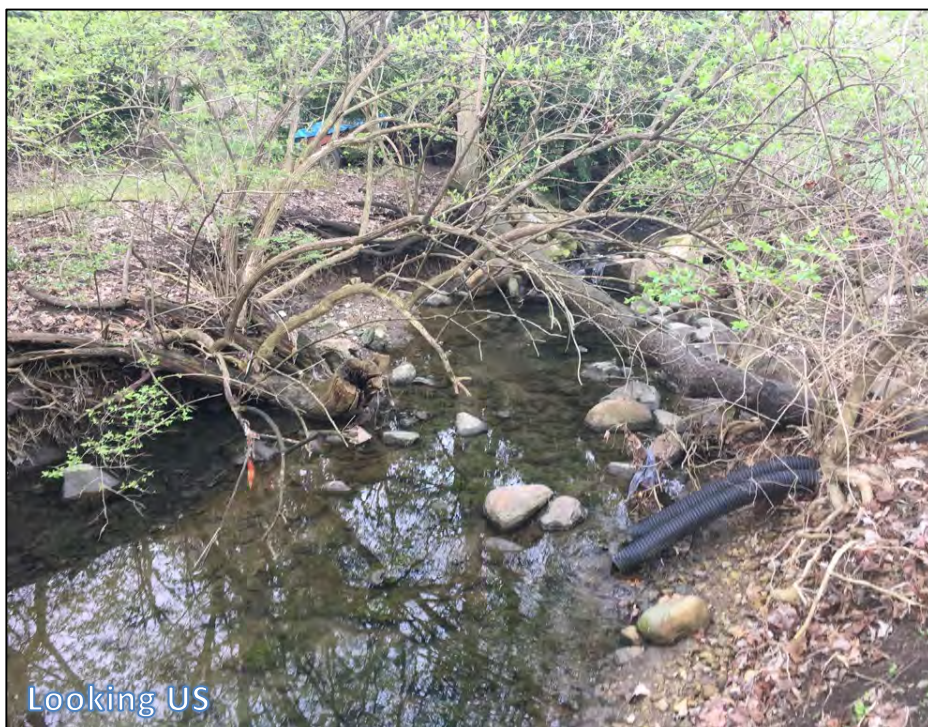
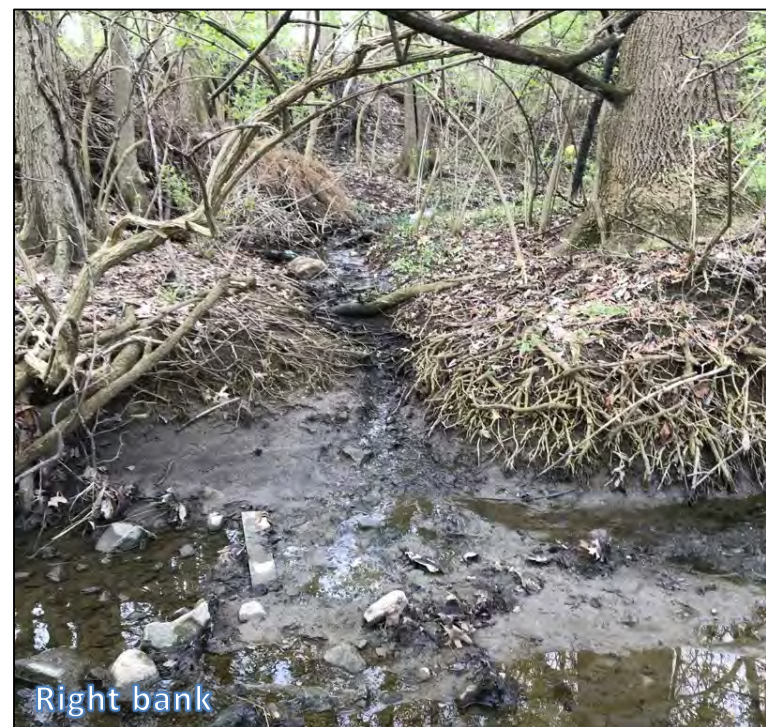
- Failing grade control
- Exposed tile drains (~4' exposed) and failing trees

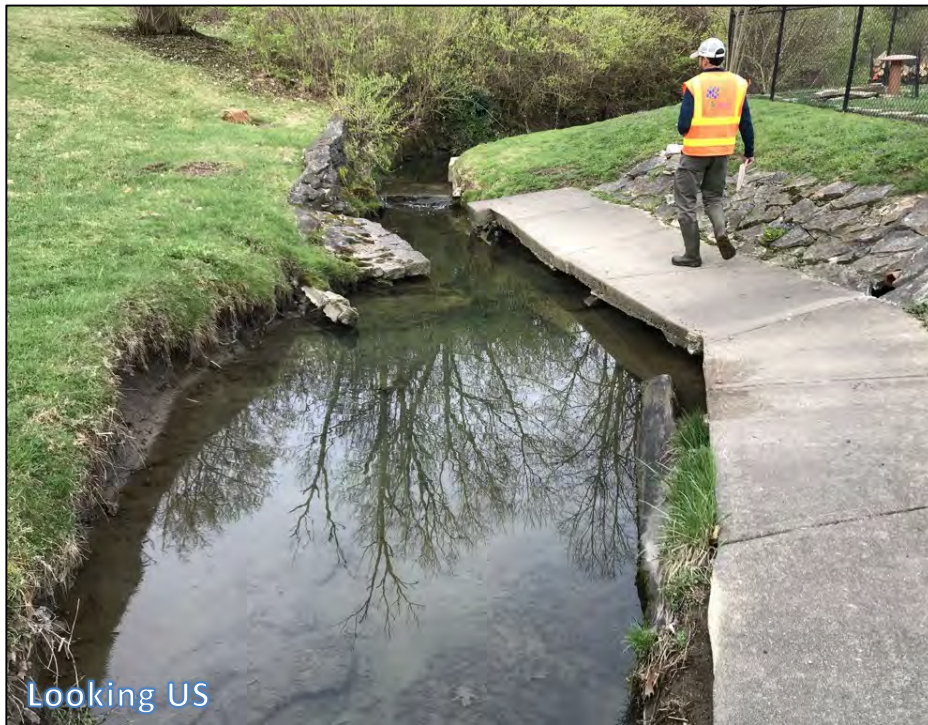
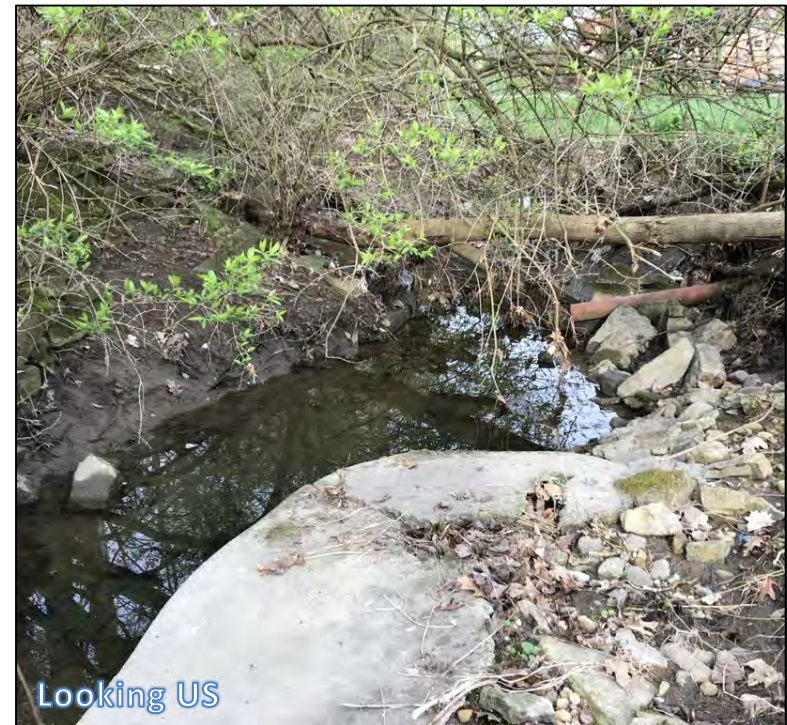
- Extensive instability near concrete sections
- Right bank lacking riparian buffer (mowed to edge) experiencing erosion
- Fish noted upstream of concrete

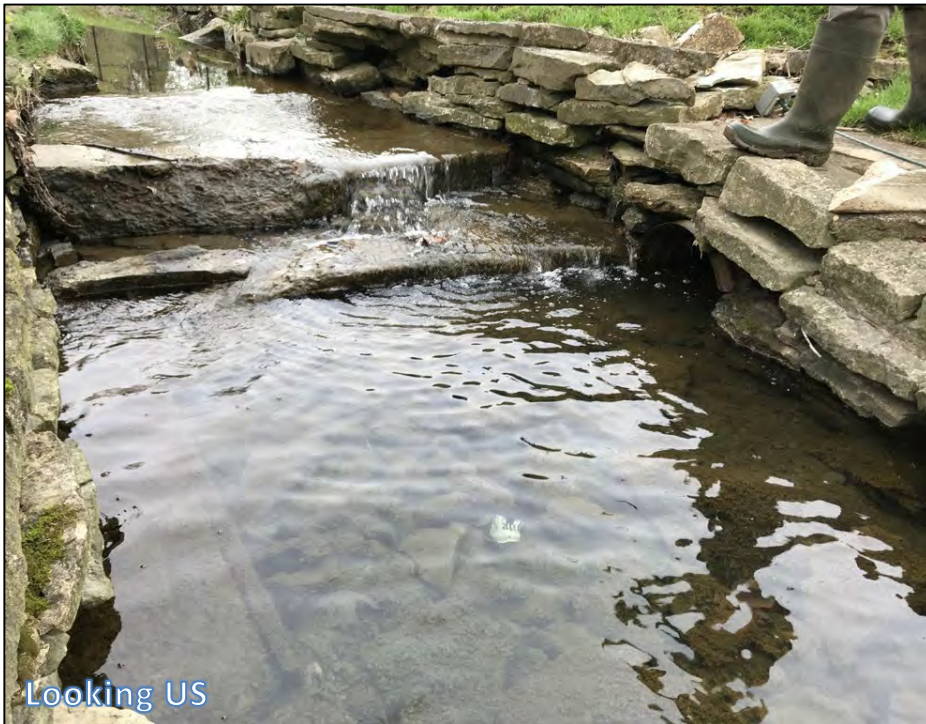
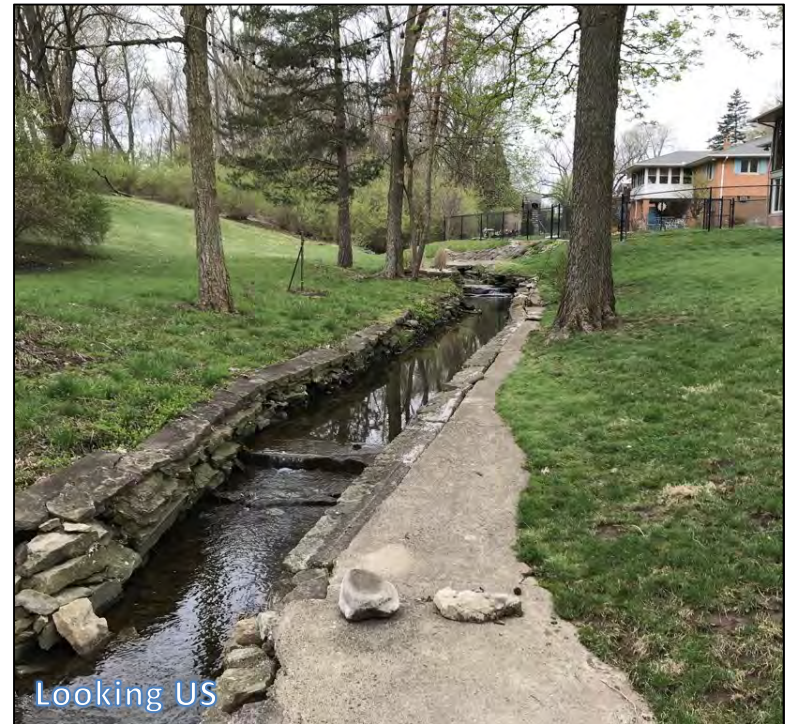
- Stormwater outfall downstream of concrete grade control
- Channelized and armored section with downcutting starting to impact armoring

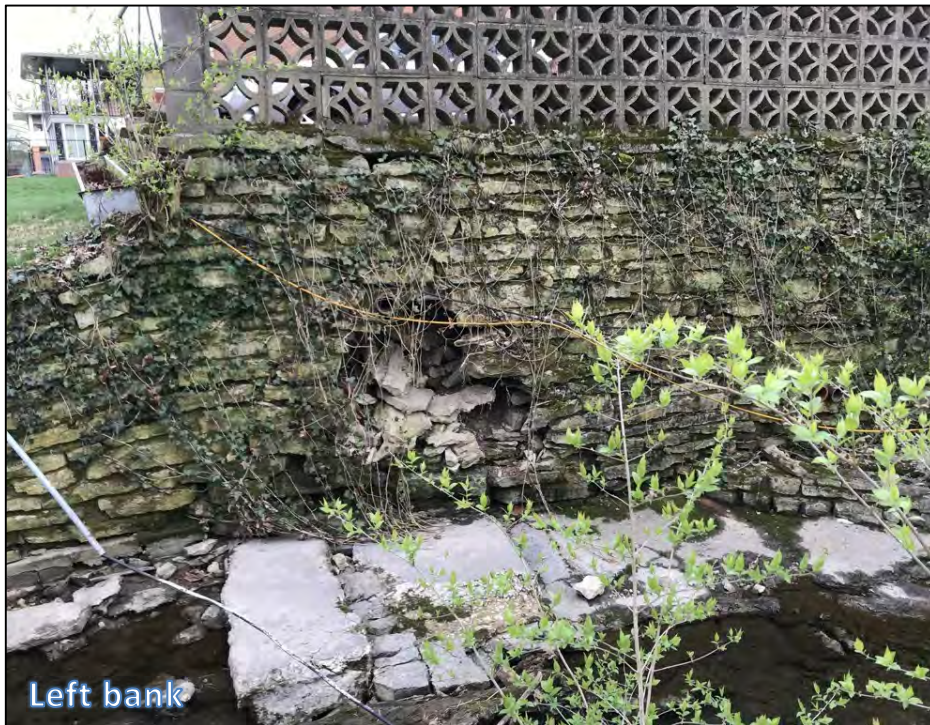
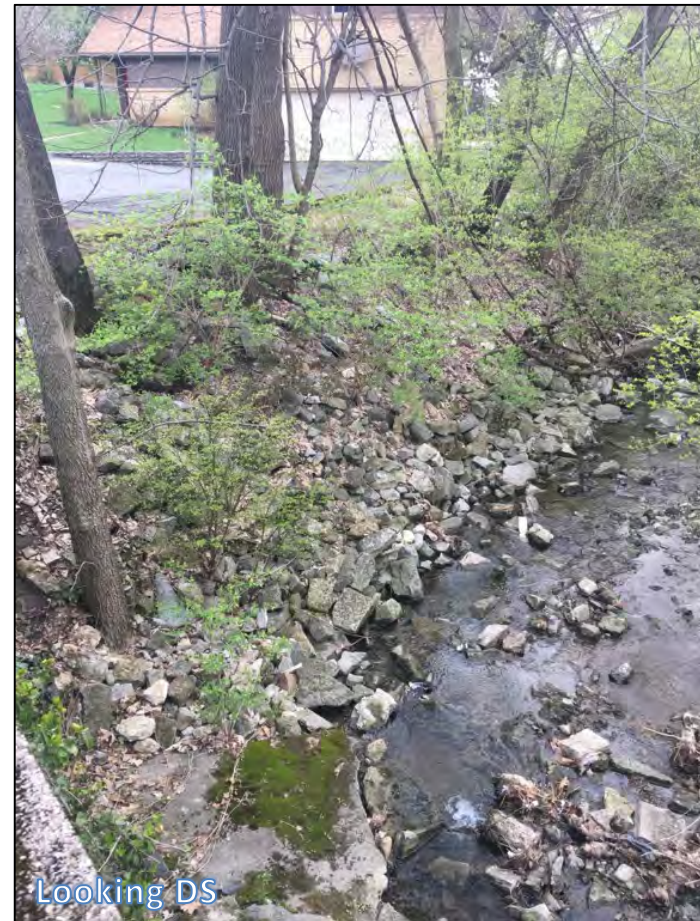
- Failing retaining wall with driveway at top
- Channelized and armored section

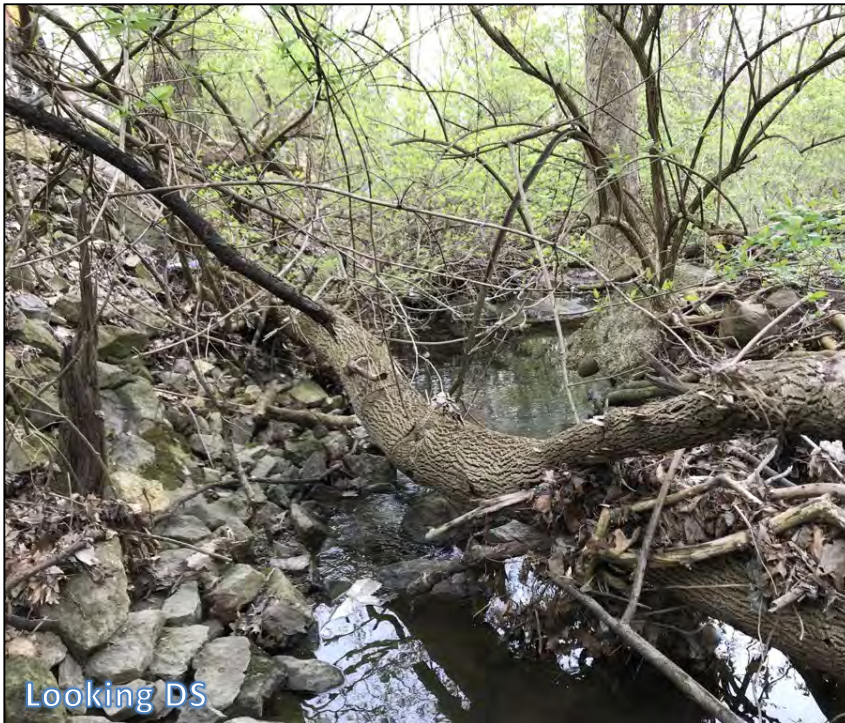
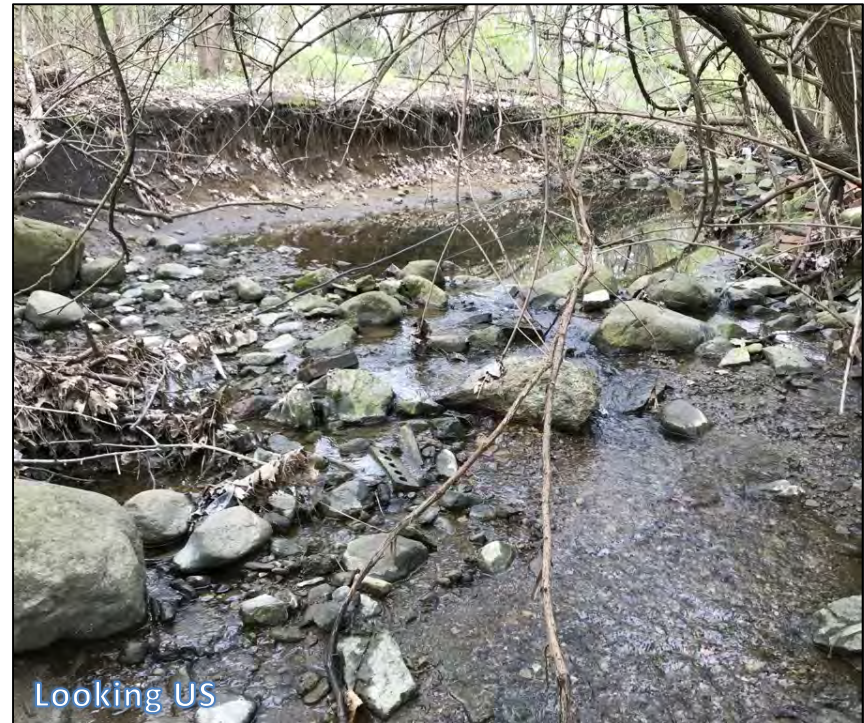
- Failed concrete armoring on right bank with possible grade control also failed
- Conduit (possibly fiber optic) runs in channel
- Over-widened in non-armored sections

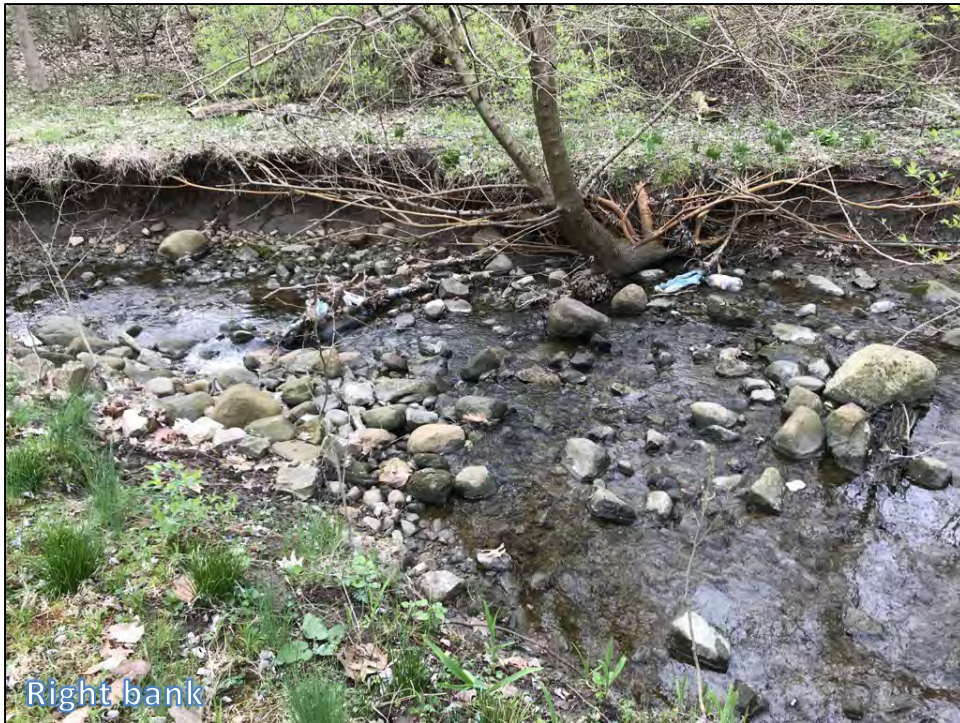
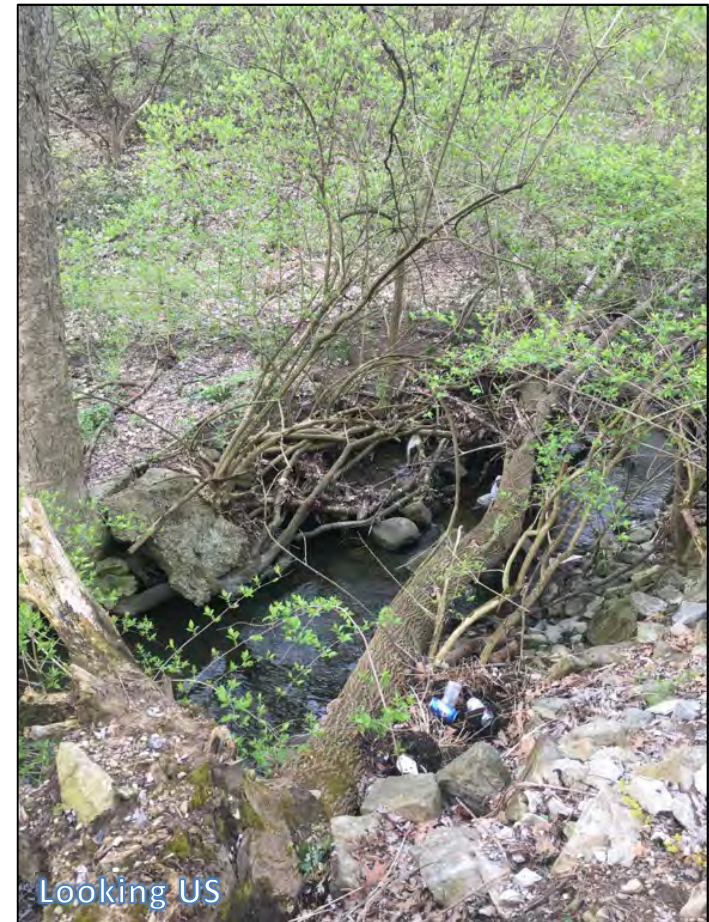
- Banks undermined with leaning trees
- Downtcutting and widening
- Crayfish noted in this reach

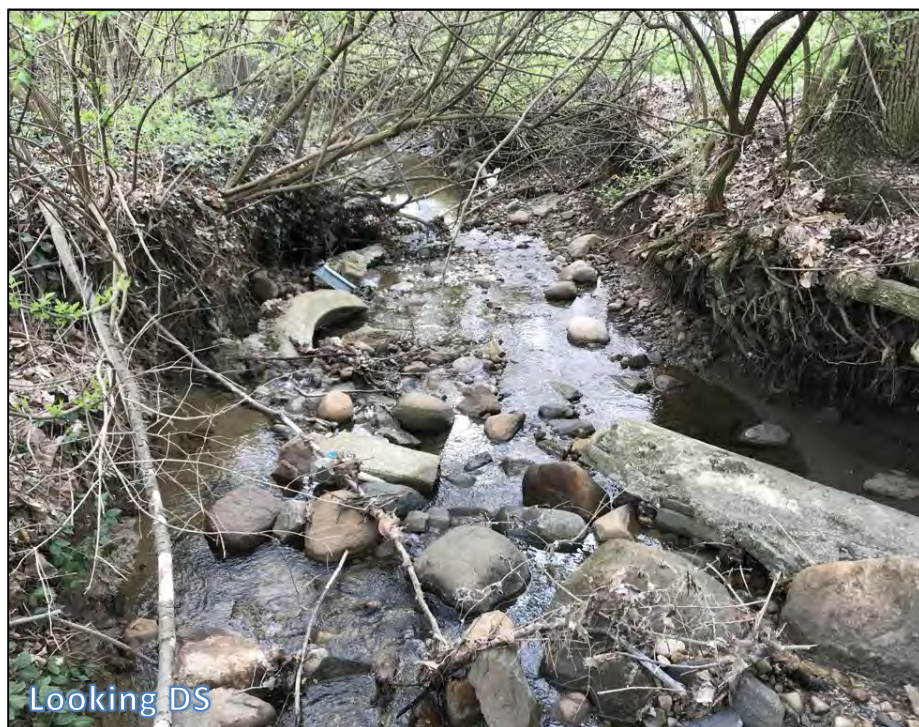
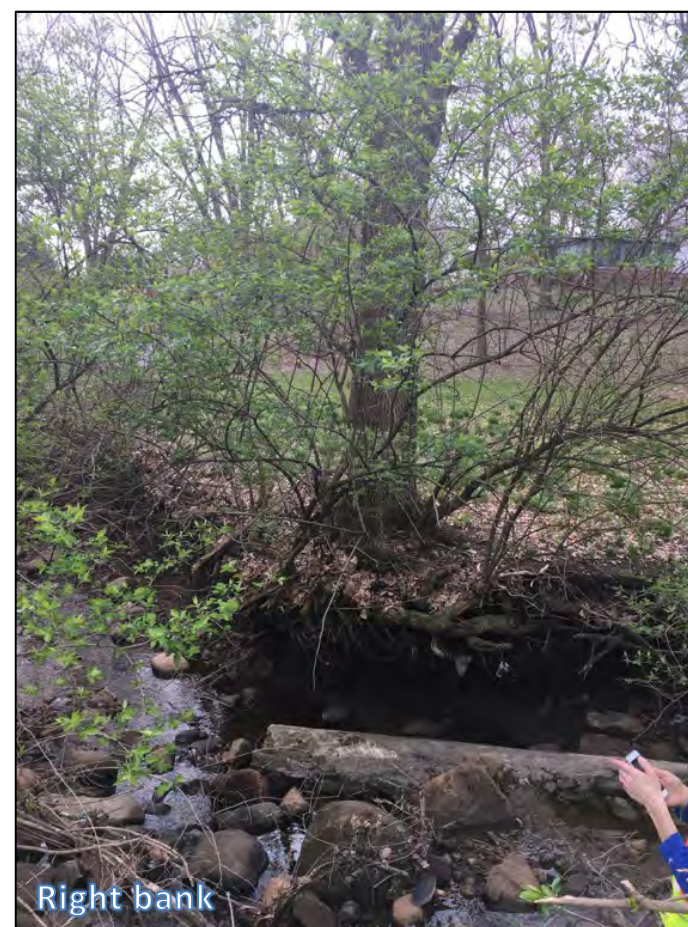
- Entrenched reach with failed concrete
- Severely undermined banks

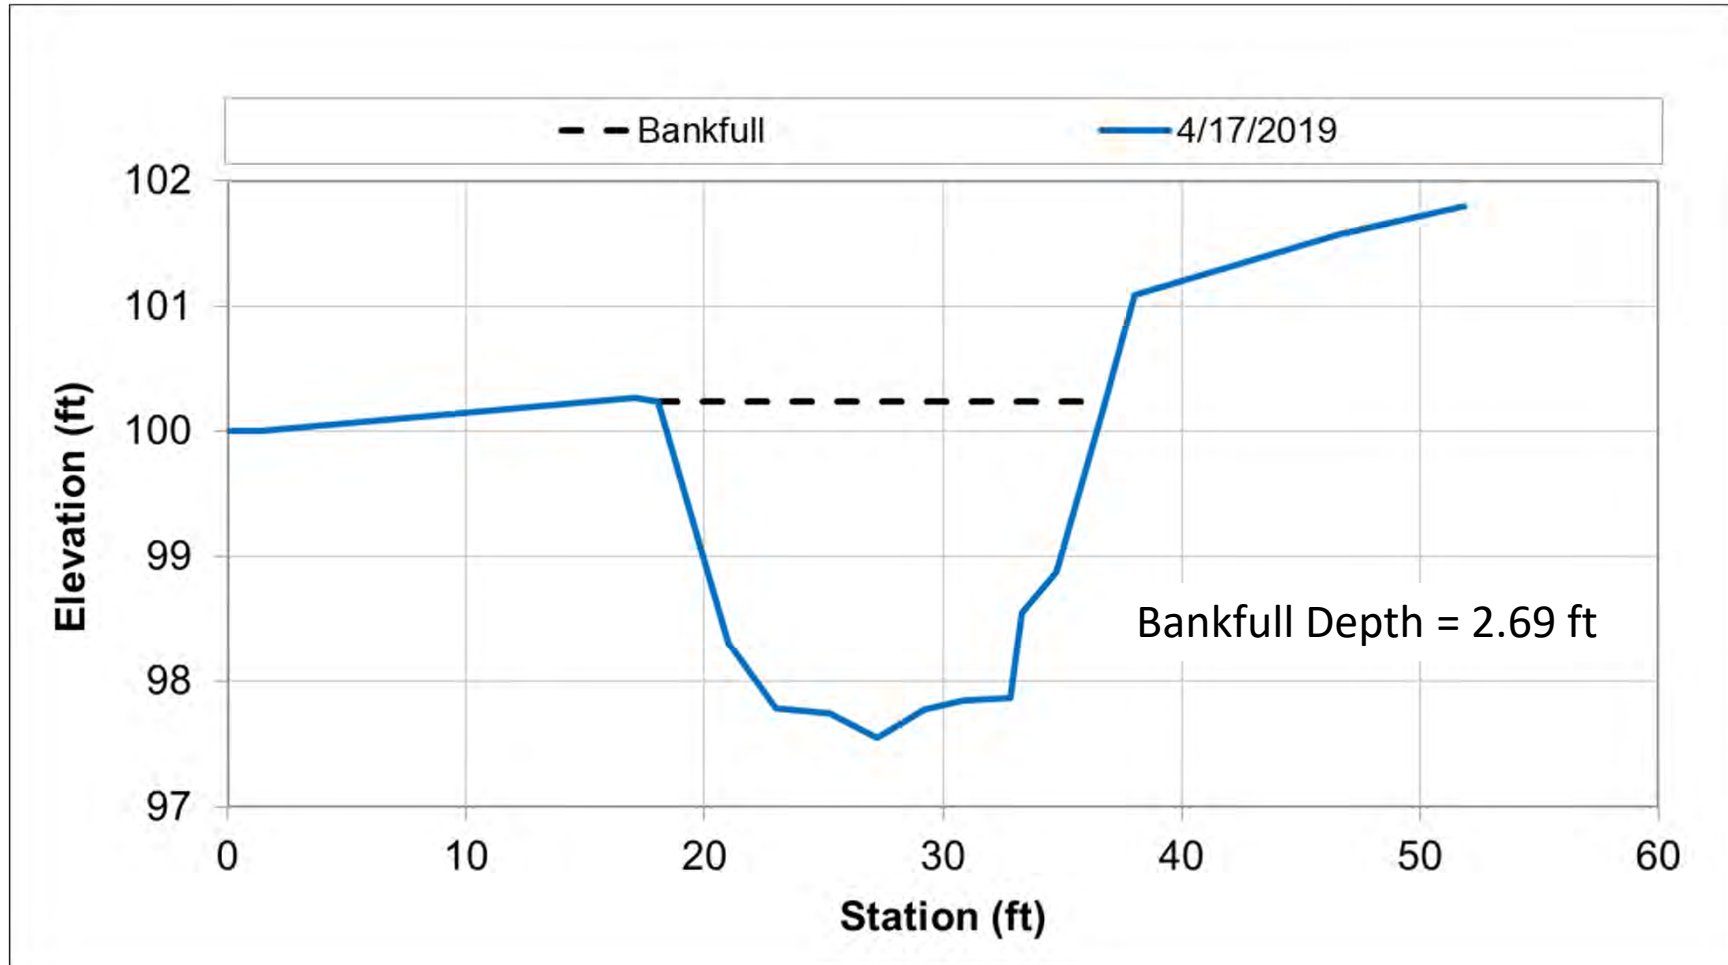
Cross Section

Cross section oriented looking downstream

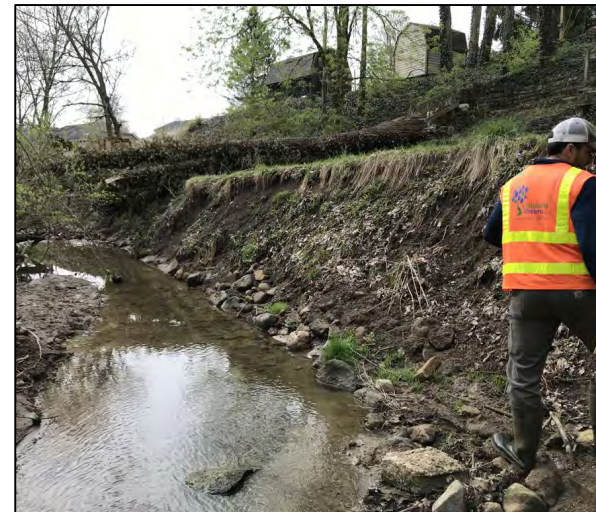
“Stage 3” reaches with geotechnically unstable banks are still likely to fail even with stormwater interventions
