## Piqua Hydraulic Canal and Dams Improvements

# System Overview for Piqua City Commission

10/11/2021

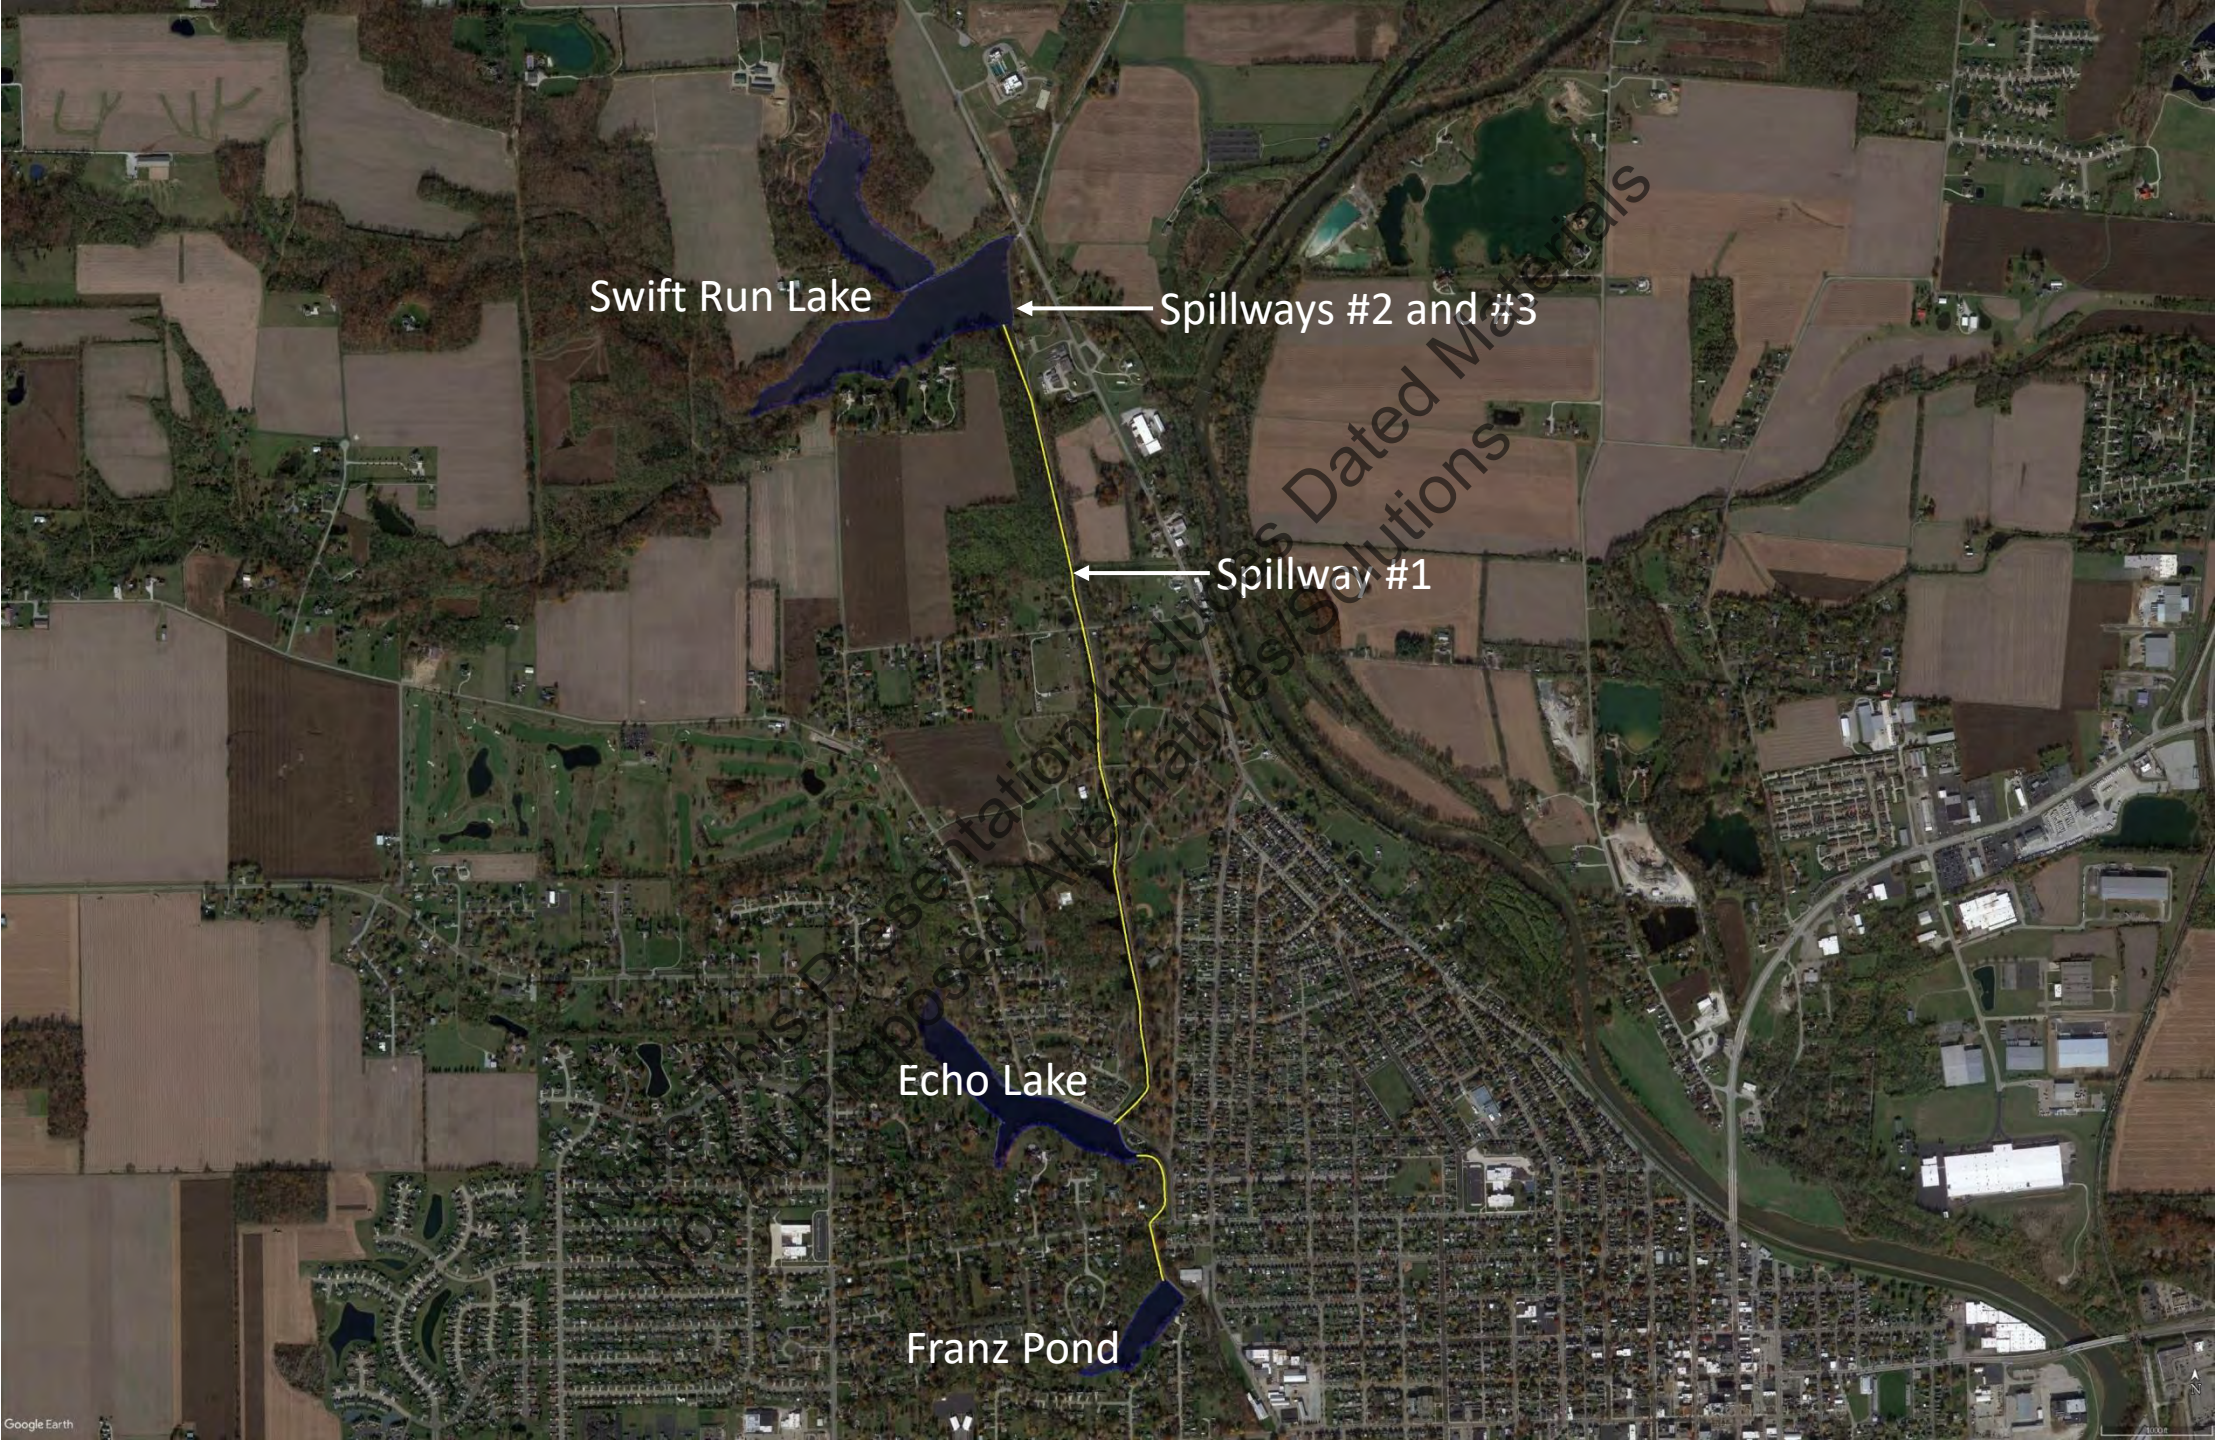
Swift Run Lake

Spillways #2 and #3

Spillway #1

Echo Lake

Franz Pond

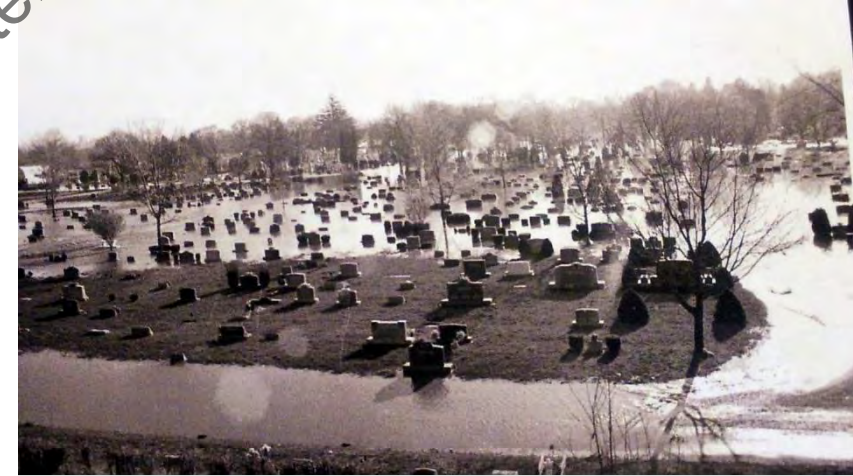
Photo 8 - Forest Hill Cemetery Flooding (1976)

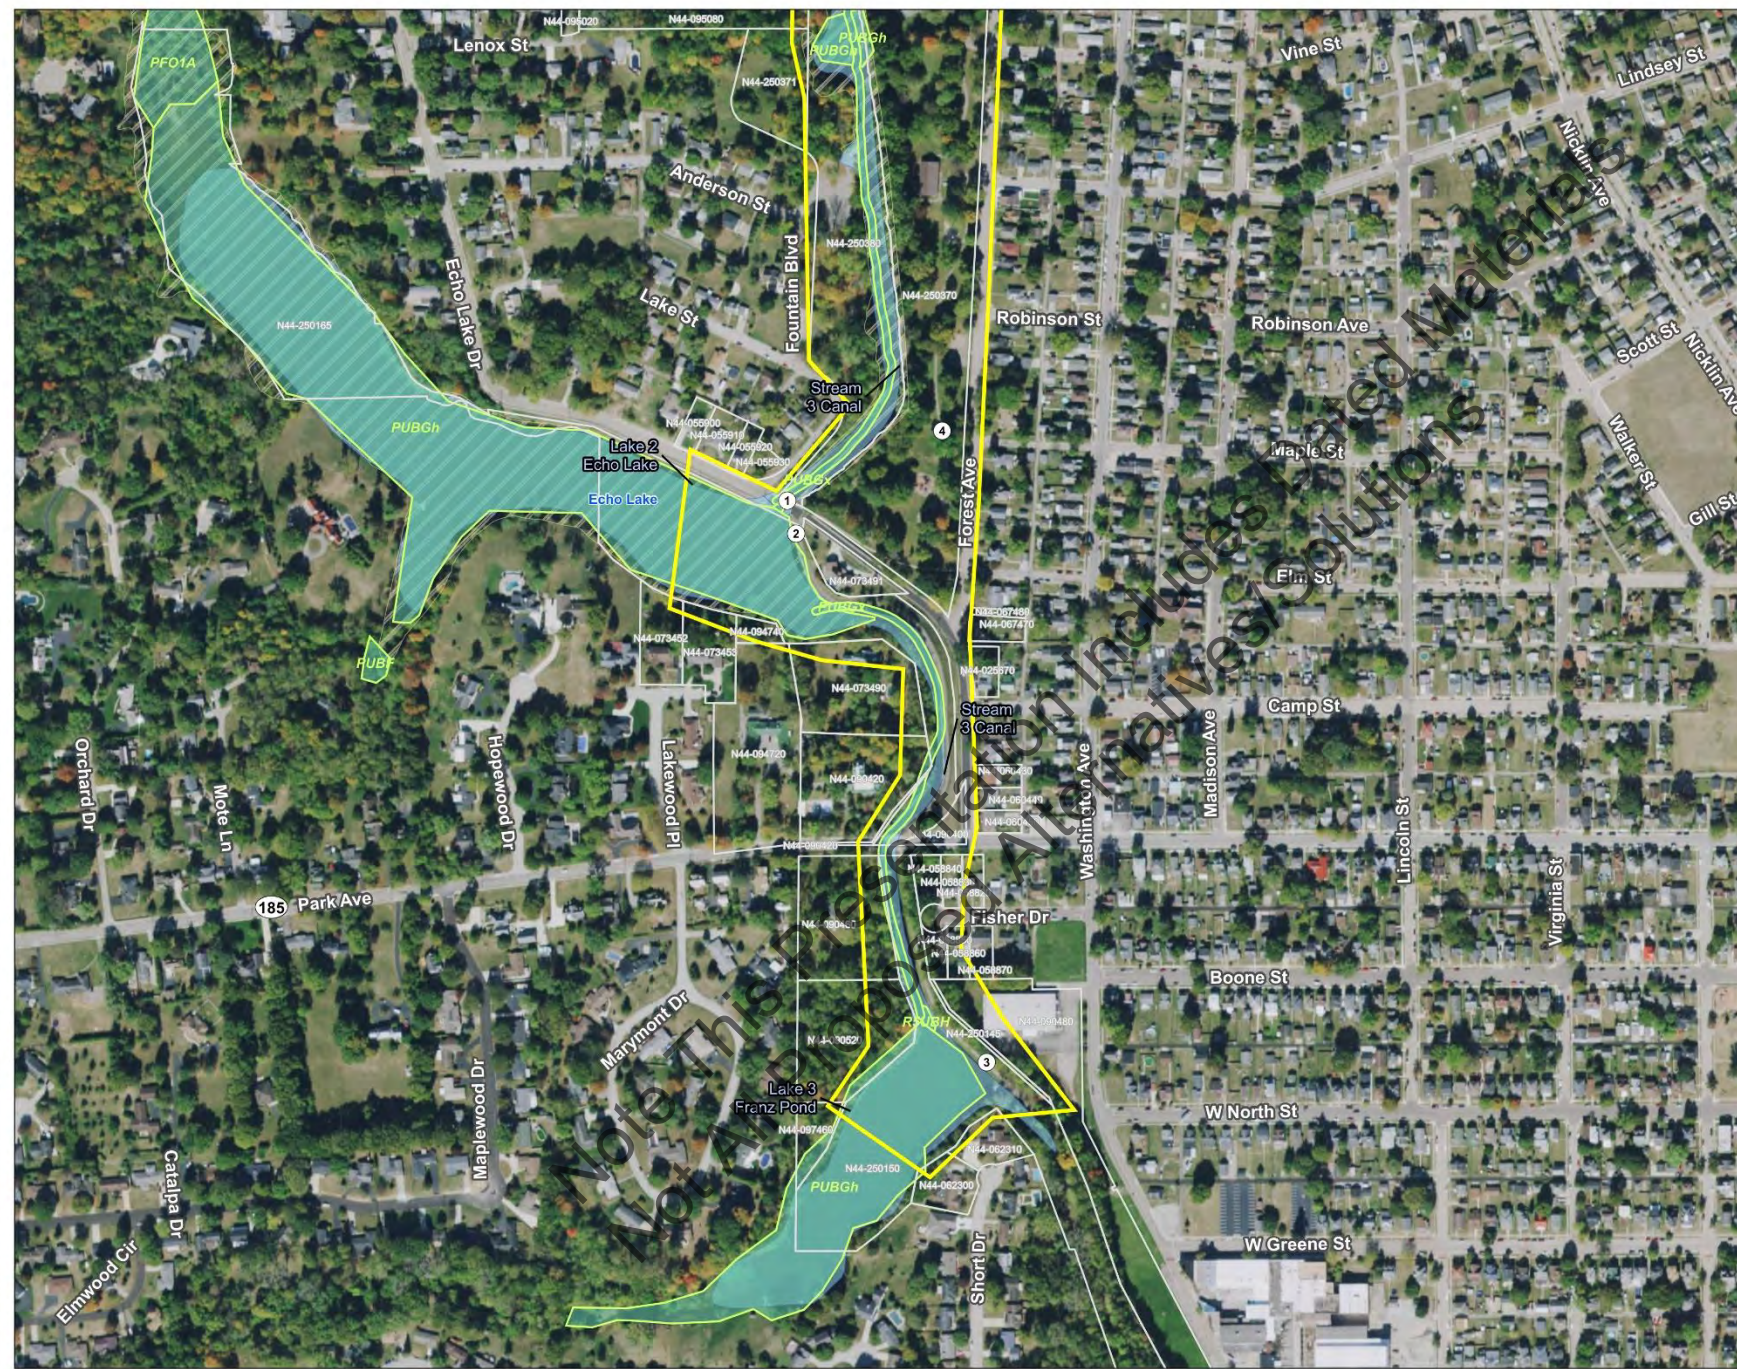
## Wetland and Waterbody Delineation Map

Note: This map includes National Wetland Inventory and FEMA Flood Hazard Areas. It is a technical drawing and does not represent a site plan. It is for informational purposes only. For more information, please contact Stantec.

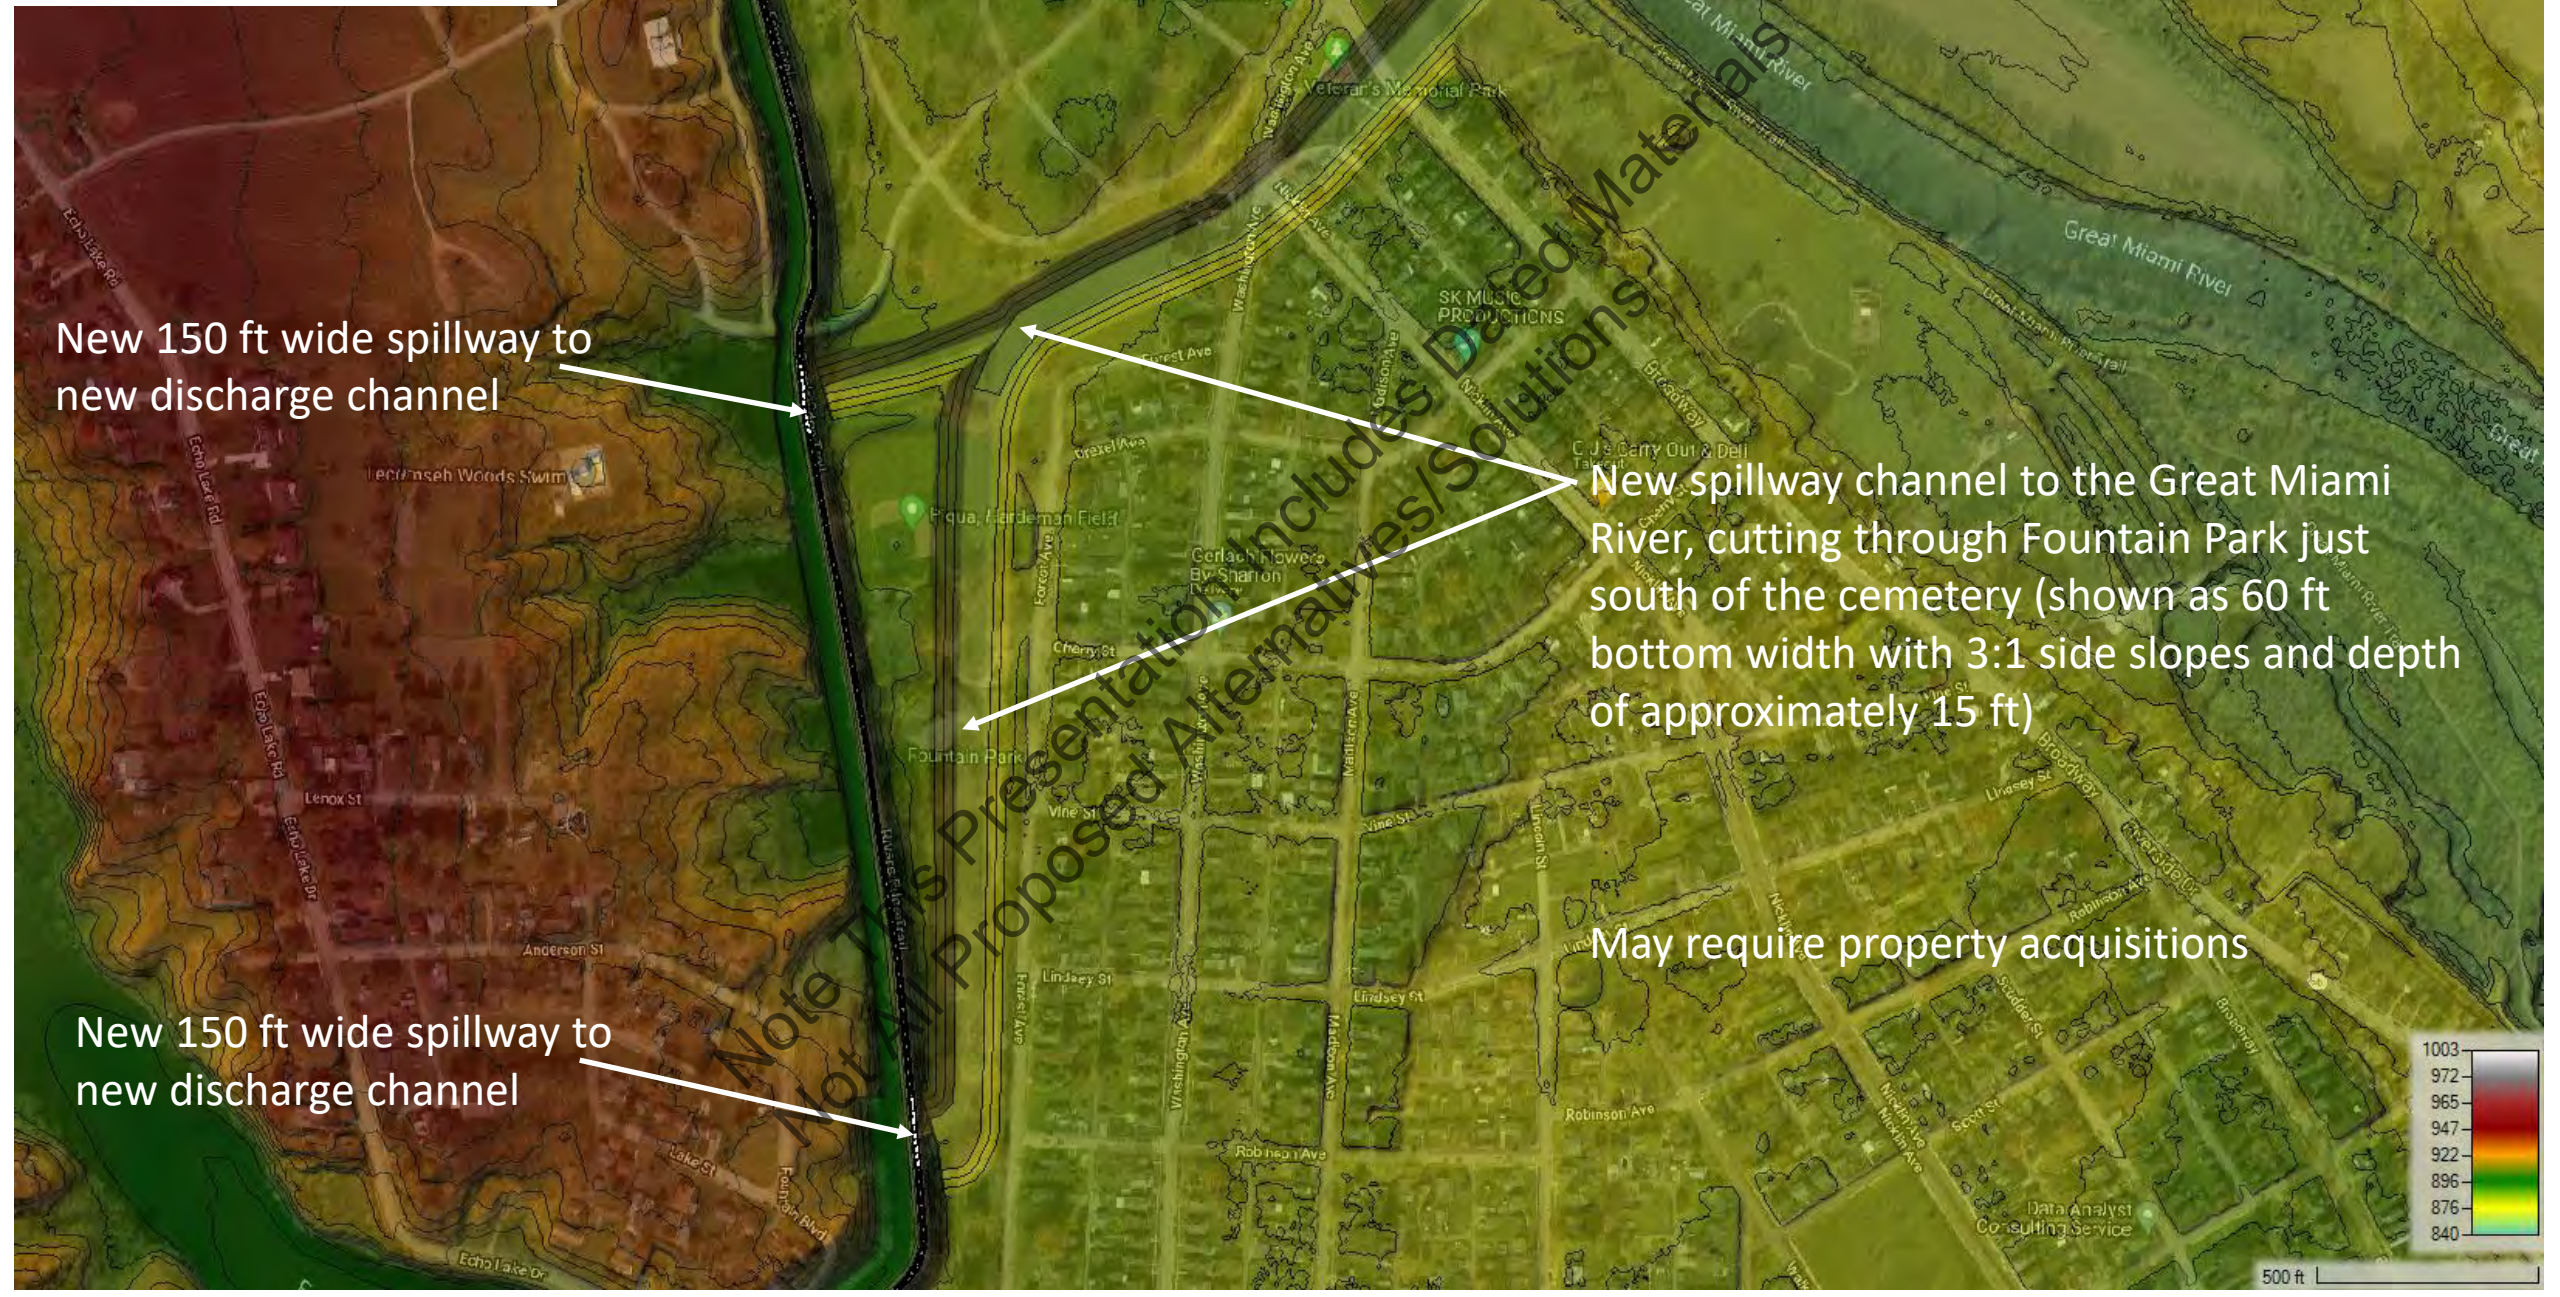
# Echo Lake Alternative 1 (continued)

New 150 ft wide spillway to new discharge channel

New spillway channel to the Great Miami River, cutting through Fountain Park just south of the cemetery (shown as 60 ft bottom width with 3:1 side slopes and depth of approximately 15 ft)

May require property acquisitions

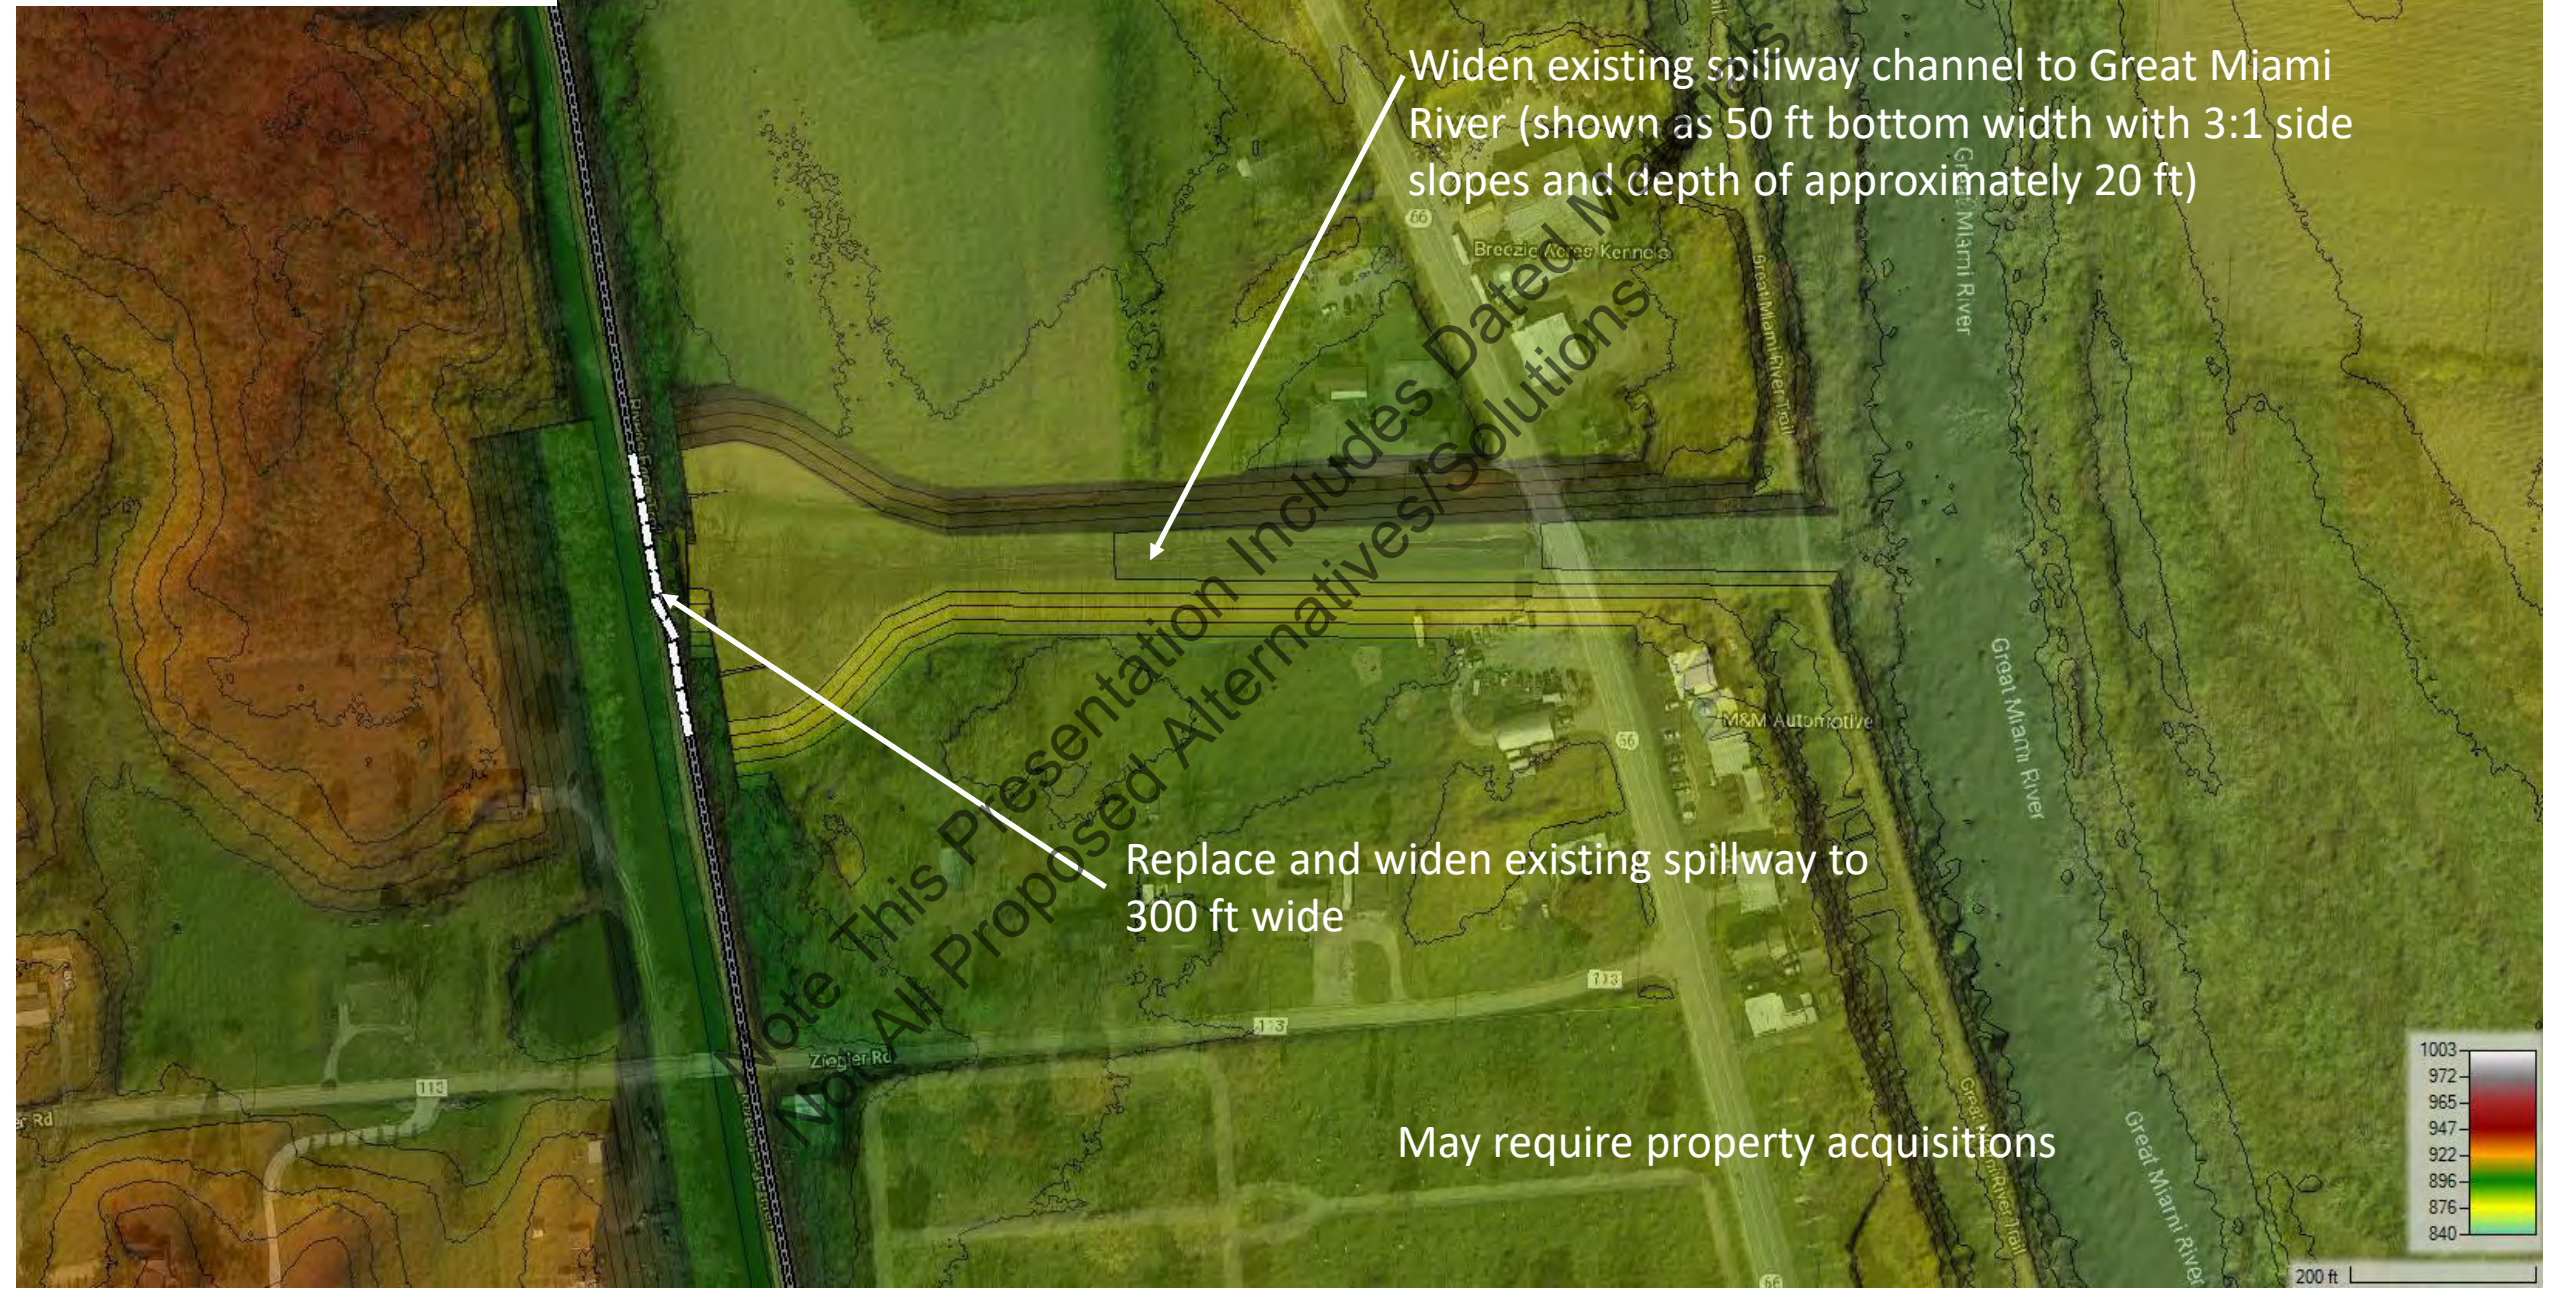
# Echo Lake Alternative 2 (continued)

Widen existing spillway channel to Great Miami River (shown as 50 ft bottom width with 3:1 side slopes and depth of approximately 20 ft)

Replace and widen existing spillway to 300 ft wide

May require property acquisitions

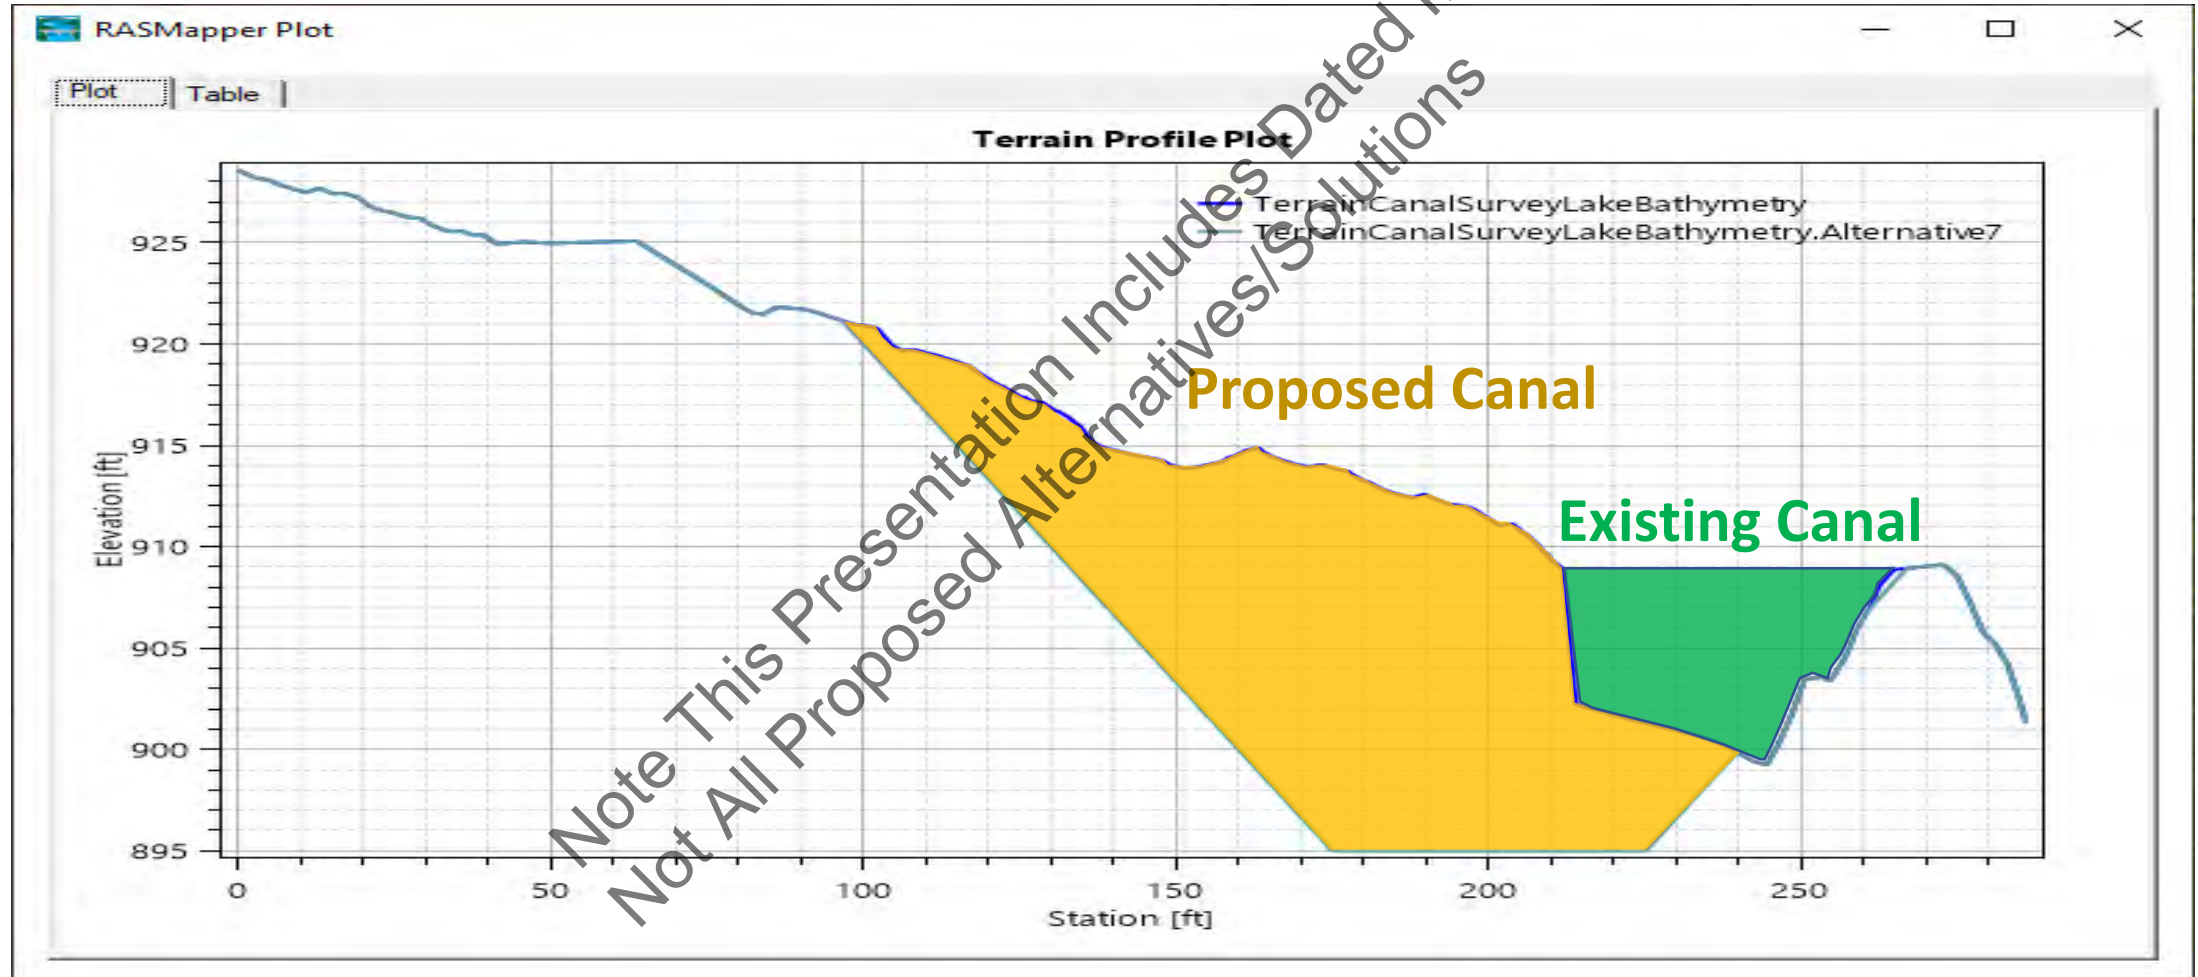
# Conceptual Cross Sections

Hydraulic Canal between Franz Pond and Echo Lake

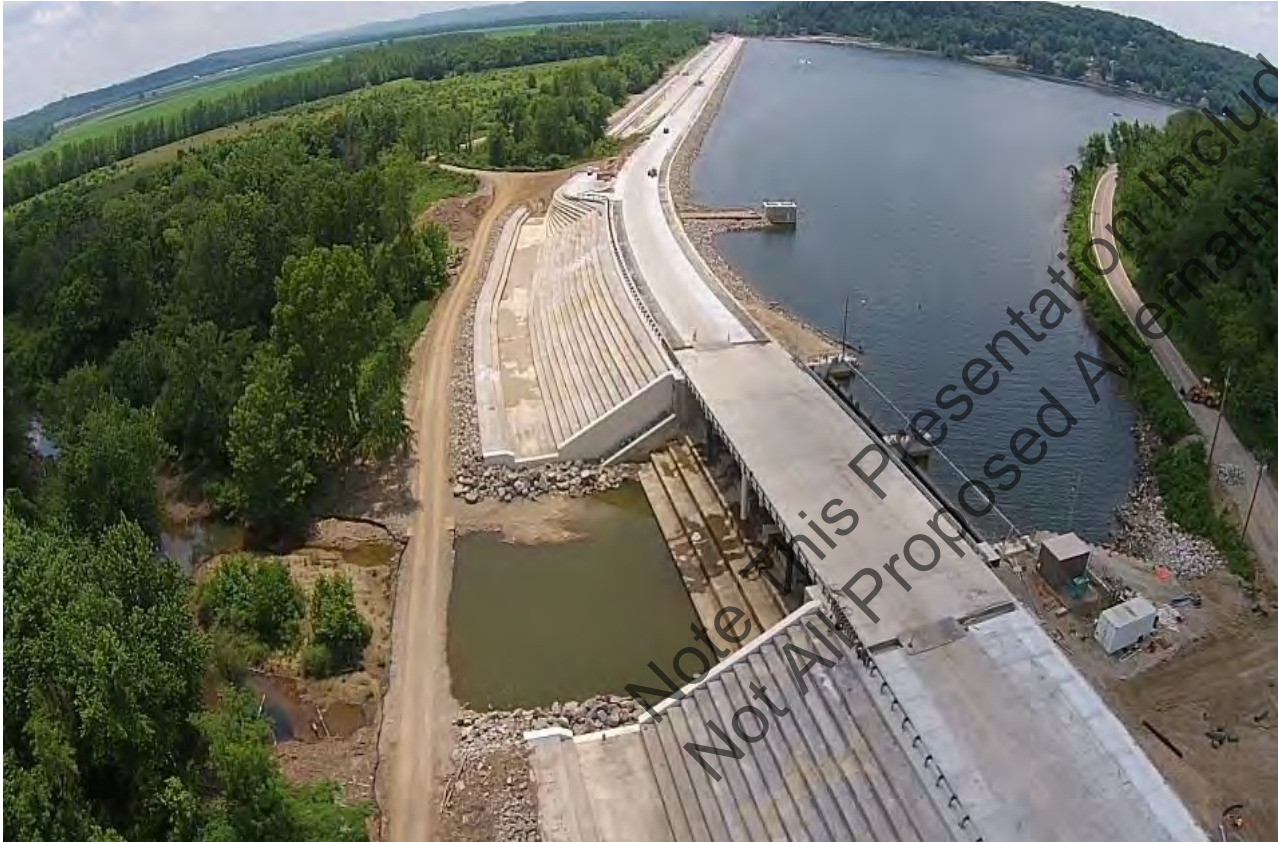
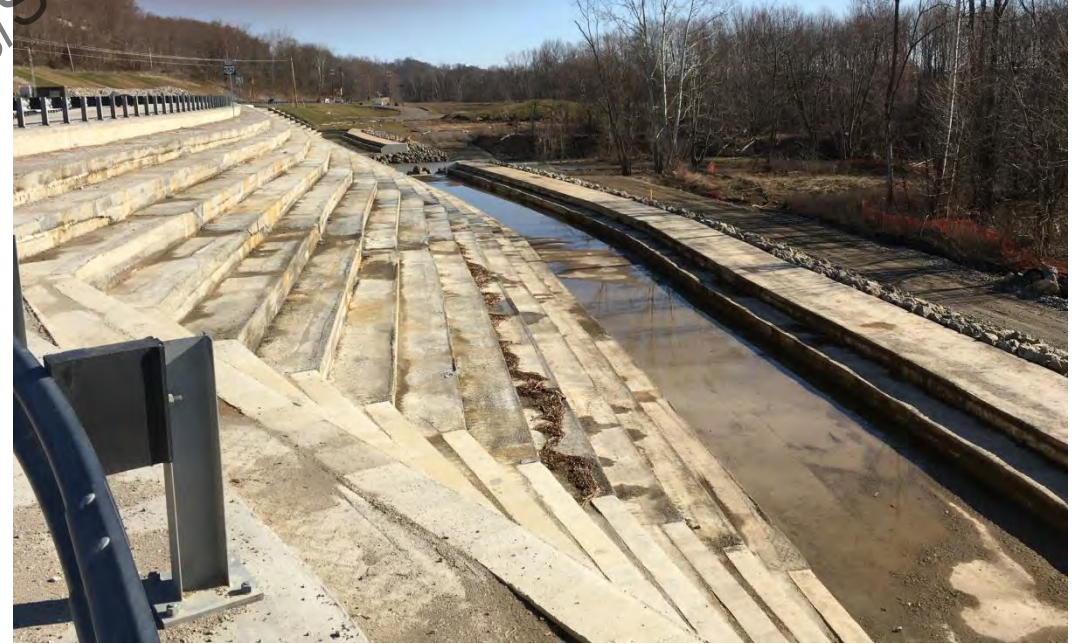
# Example of Alternatives

Roller Compacted Concrete (RCC) Overtopping Protection

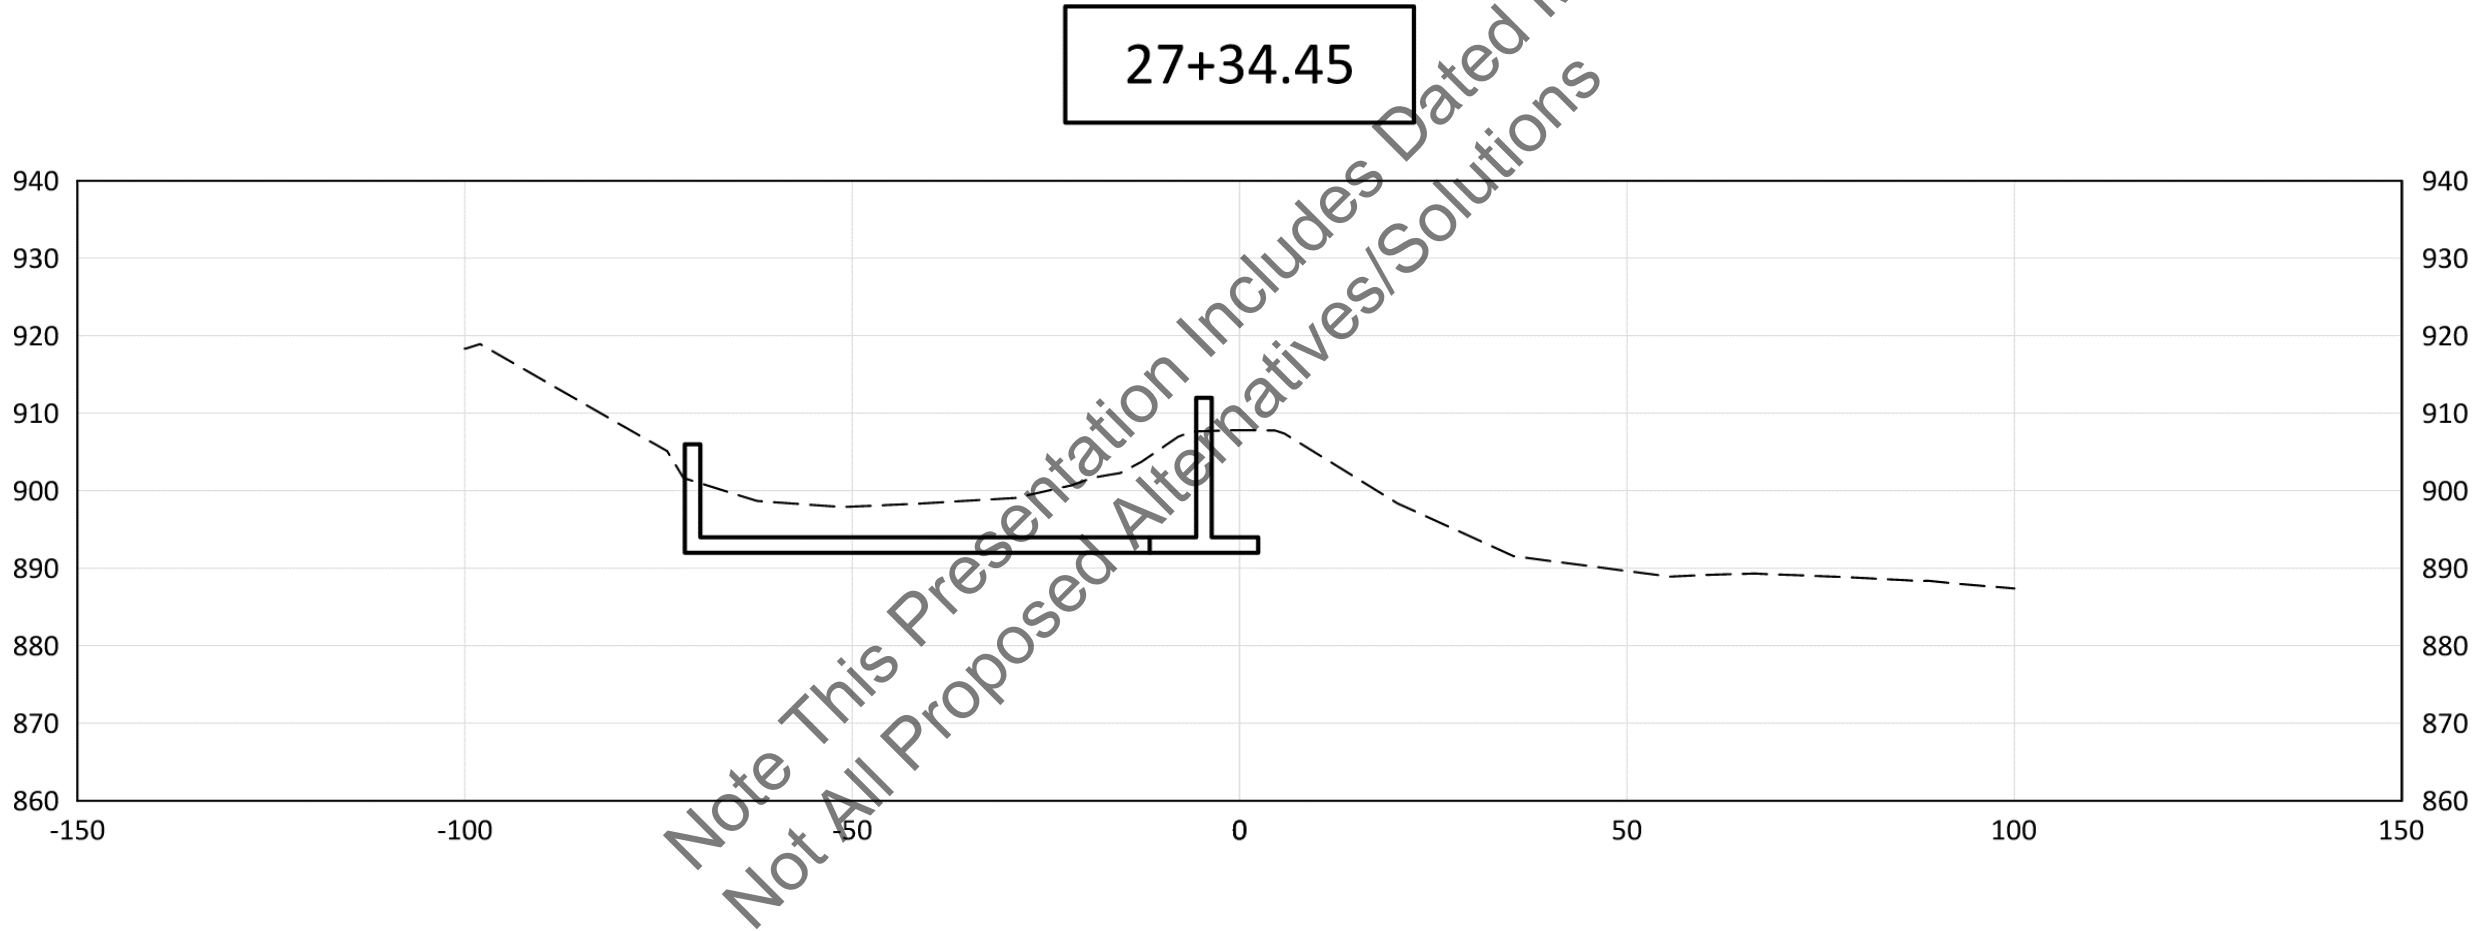
# Potential Canal Modification

- Lower normal pool of all lakes by ~2 ft.
- Replace and widen Swift Run Lake spillway.
- Raise Echo and Franz dam embankments.
- Widen canal between Echo Lake and Franz Pond.
- Widen canal from Echo Lake to the existing standalone spillway (concrete rectangular channel through cemetery).
- Replace and widen standalone spillway and widen spillway discharge channel.

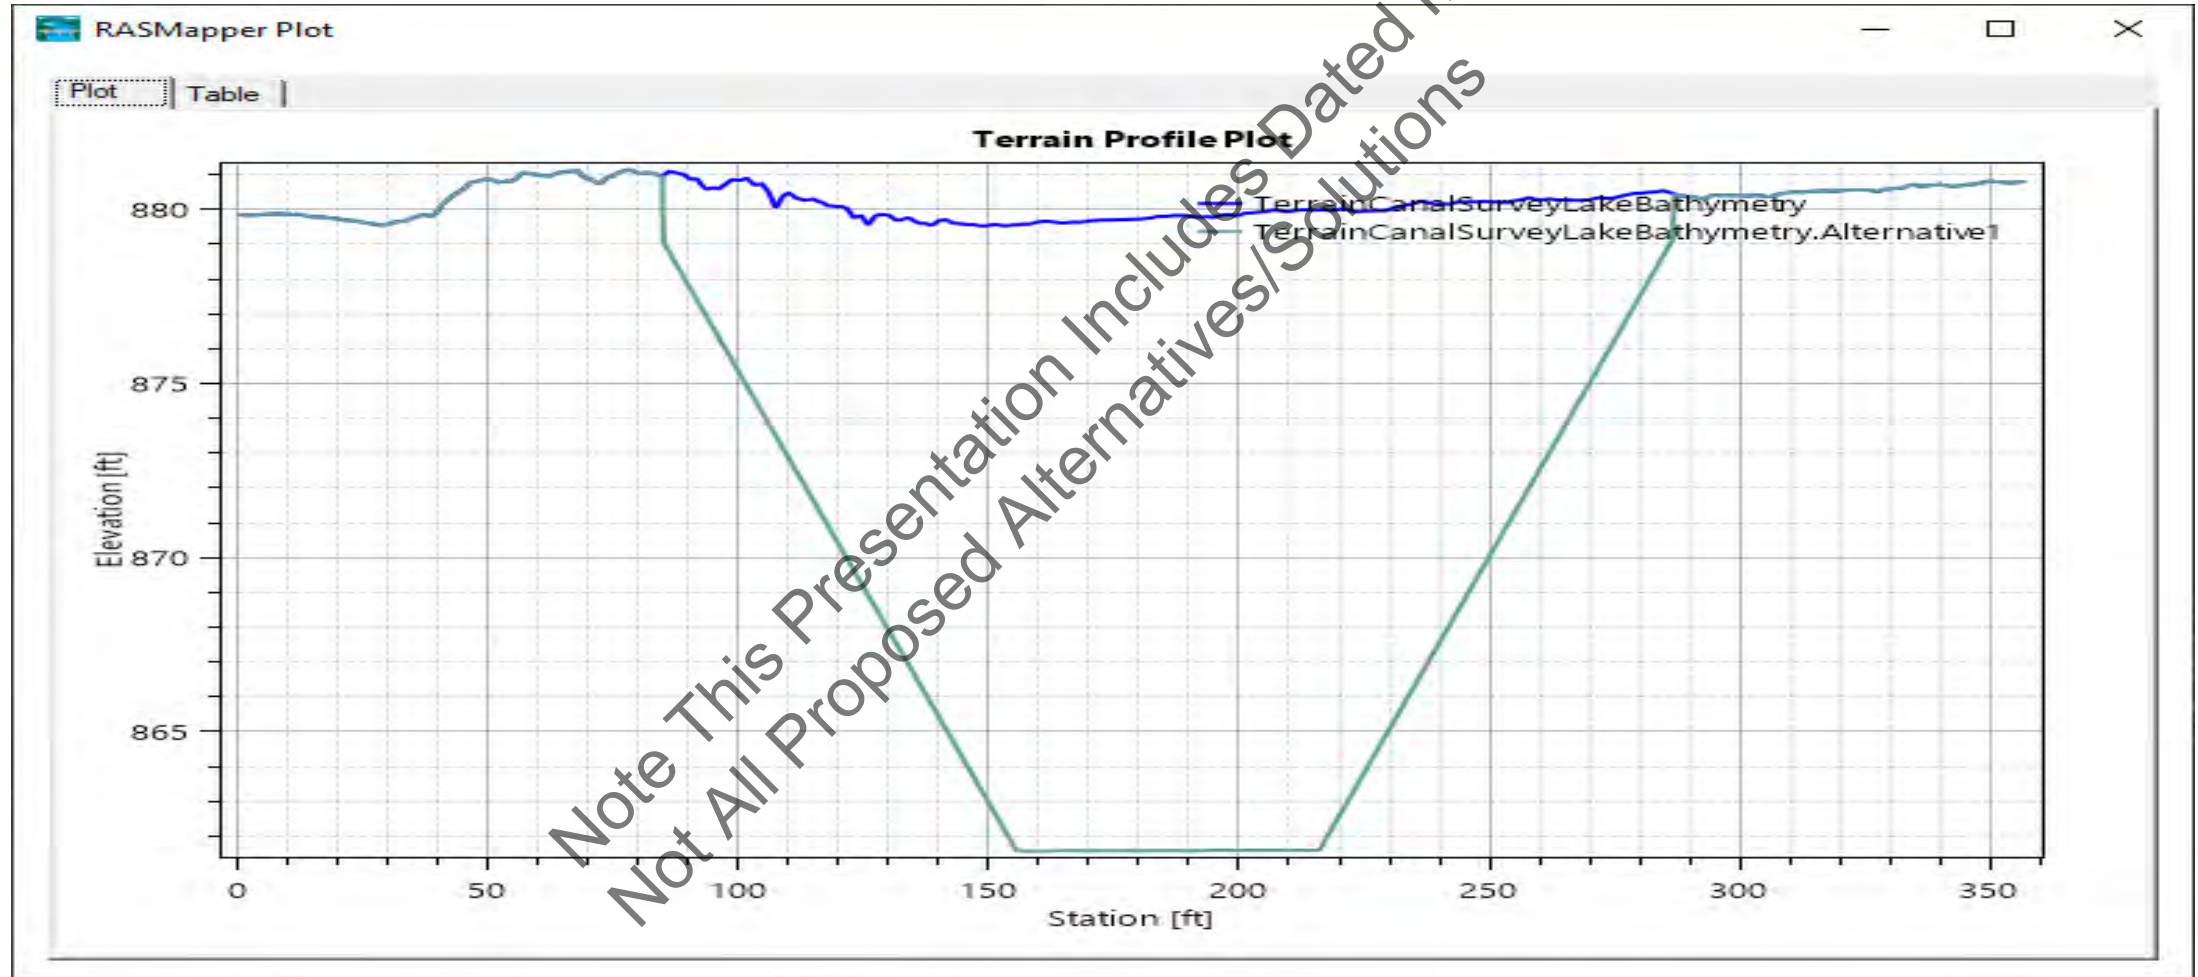
# Conceptual Cross Sections

Alternative 1 Spillway near HWY 66 (Broadway) Crossing
